Agenda

Board of Trustees, District No. 20

Walla Walla Community College

Wednesday, May 17, 2017

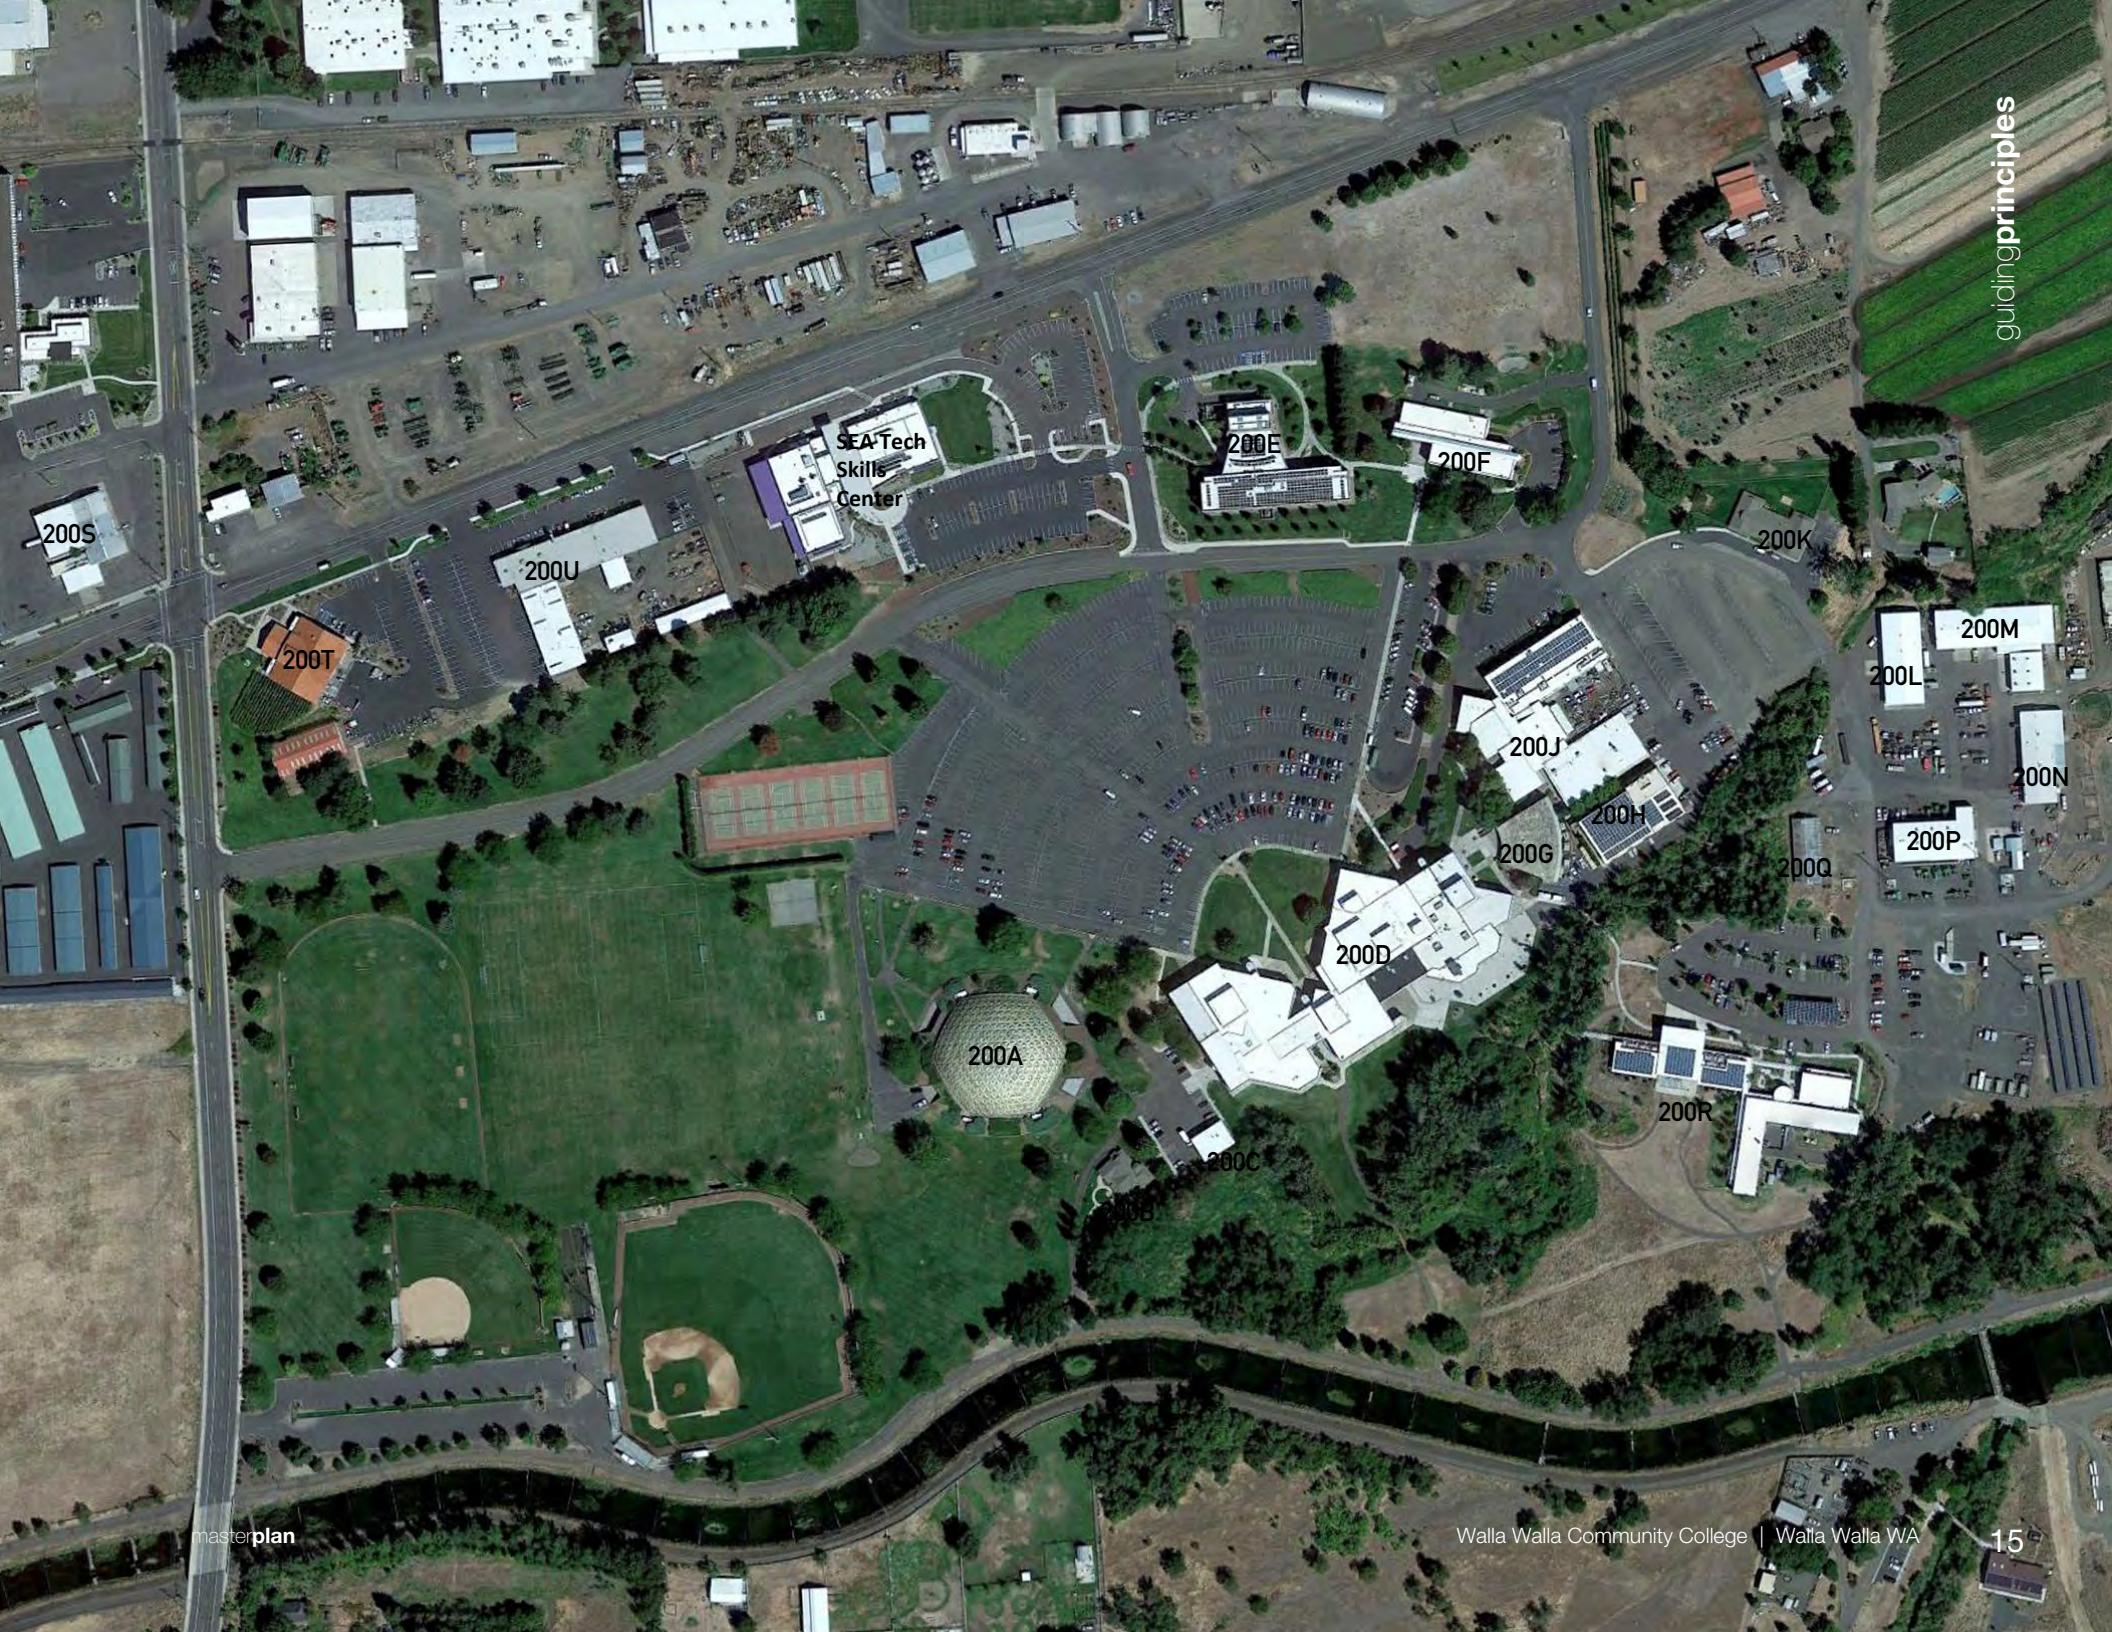
Right: The current aerial of the Walla Walla Campus including all existing structures, parking, and amenities. Reference the key above for building locations and additional information.

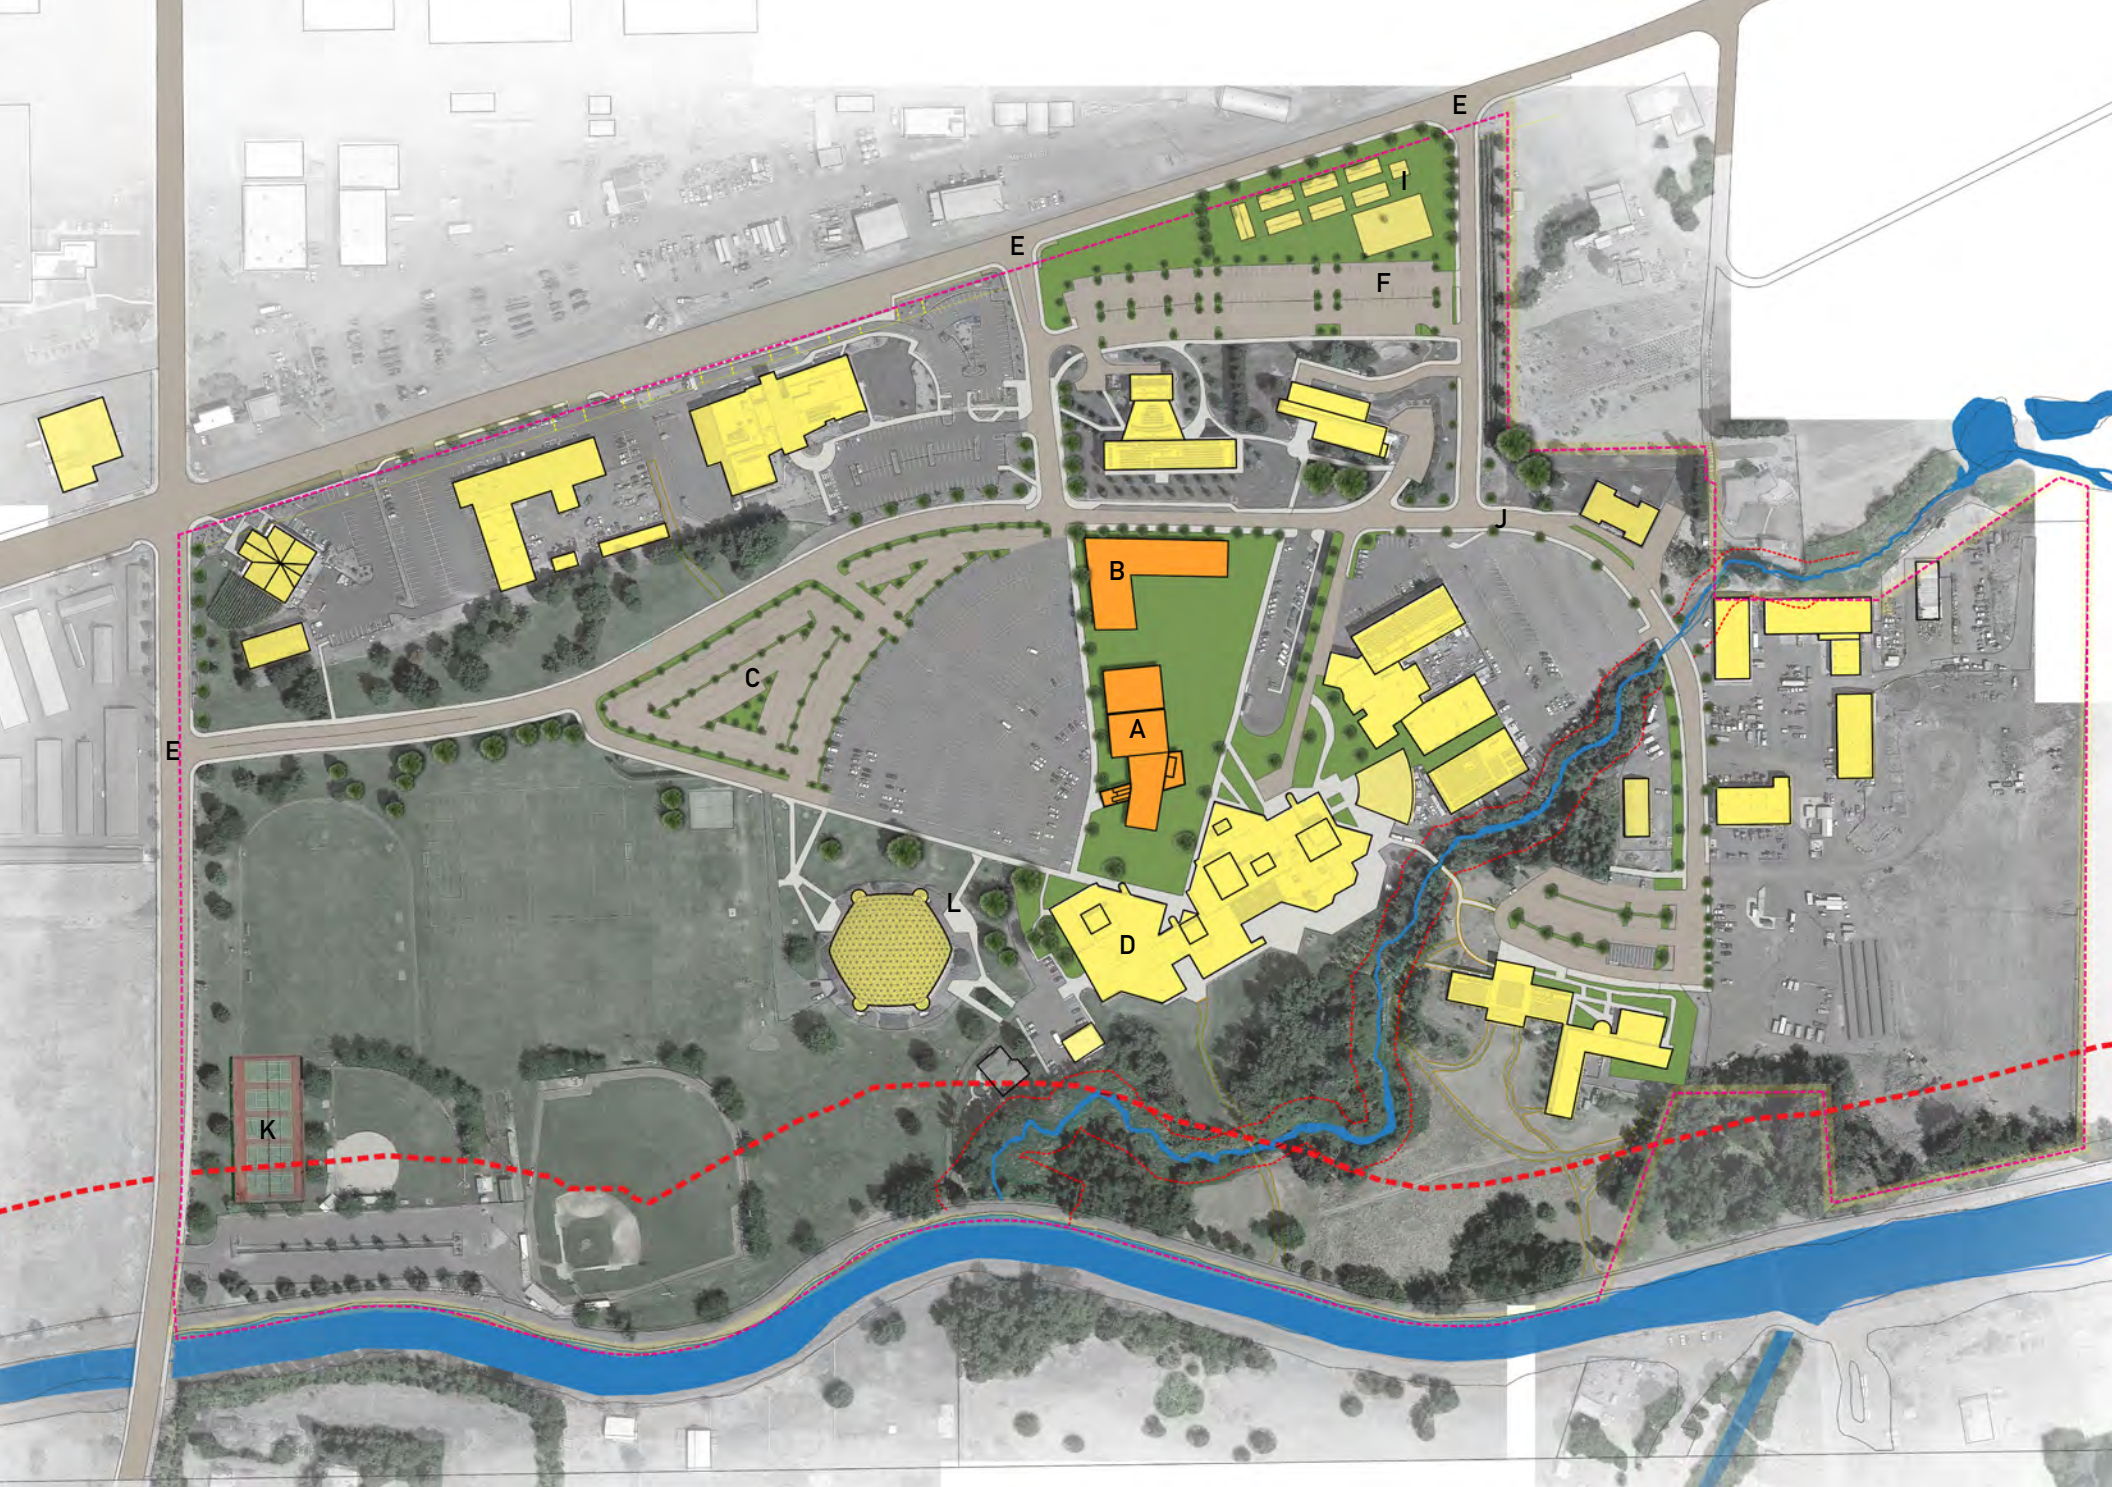
immediate priorities

- A** Student Recreation Center: Design and construct.
- B** Science and Technology Building: Obtain additional funding, design and construct.
- C** Parking Replacement: Develop parking north of Tech Center and at north end of main lot to replace parking lost when Recreation Center and Science and Technology Buildings are constructed.

- I** Landscape along Isaacs: Plant native grasses at northeast corner of Campus along Isaacs.
- J** Improve Roadway to Water Center: Improve Roadway to Water Center, John Deere Center, and Eastern Campus Area. Include landscaping on both sides of road.

- K** Relocate Tennis Courts.
- L** Improve ADA access to Dome.

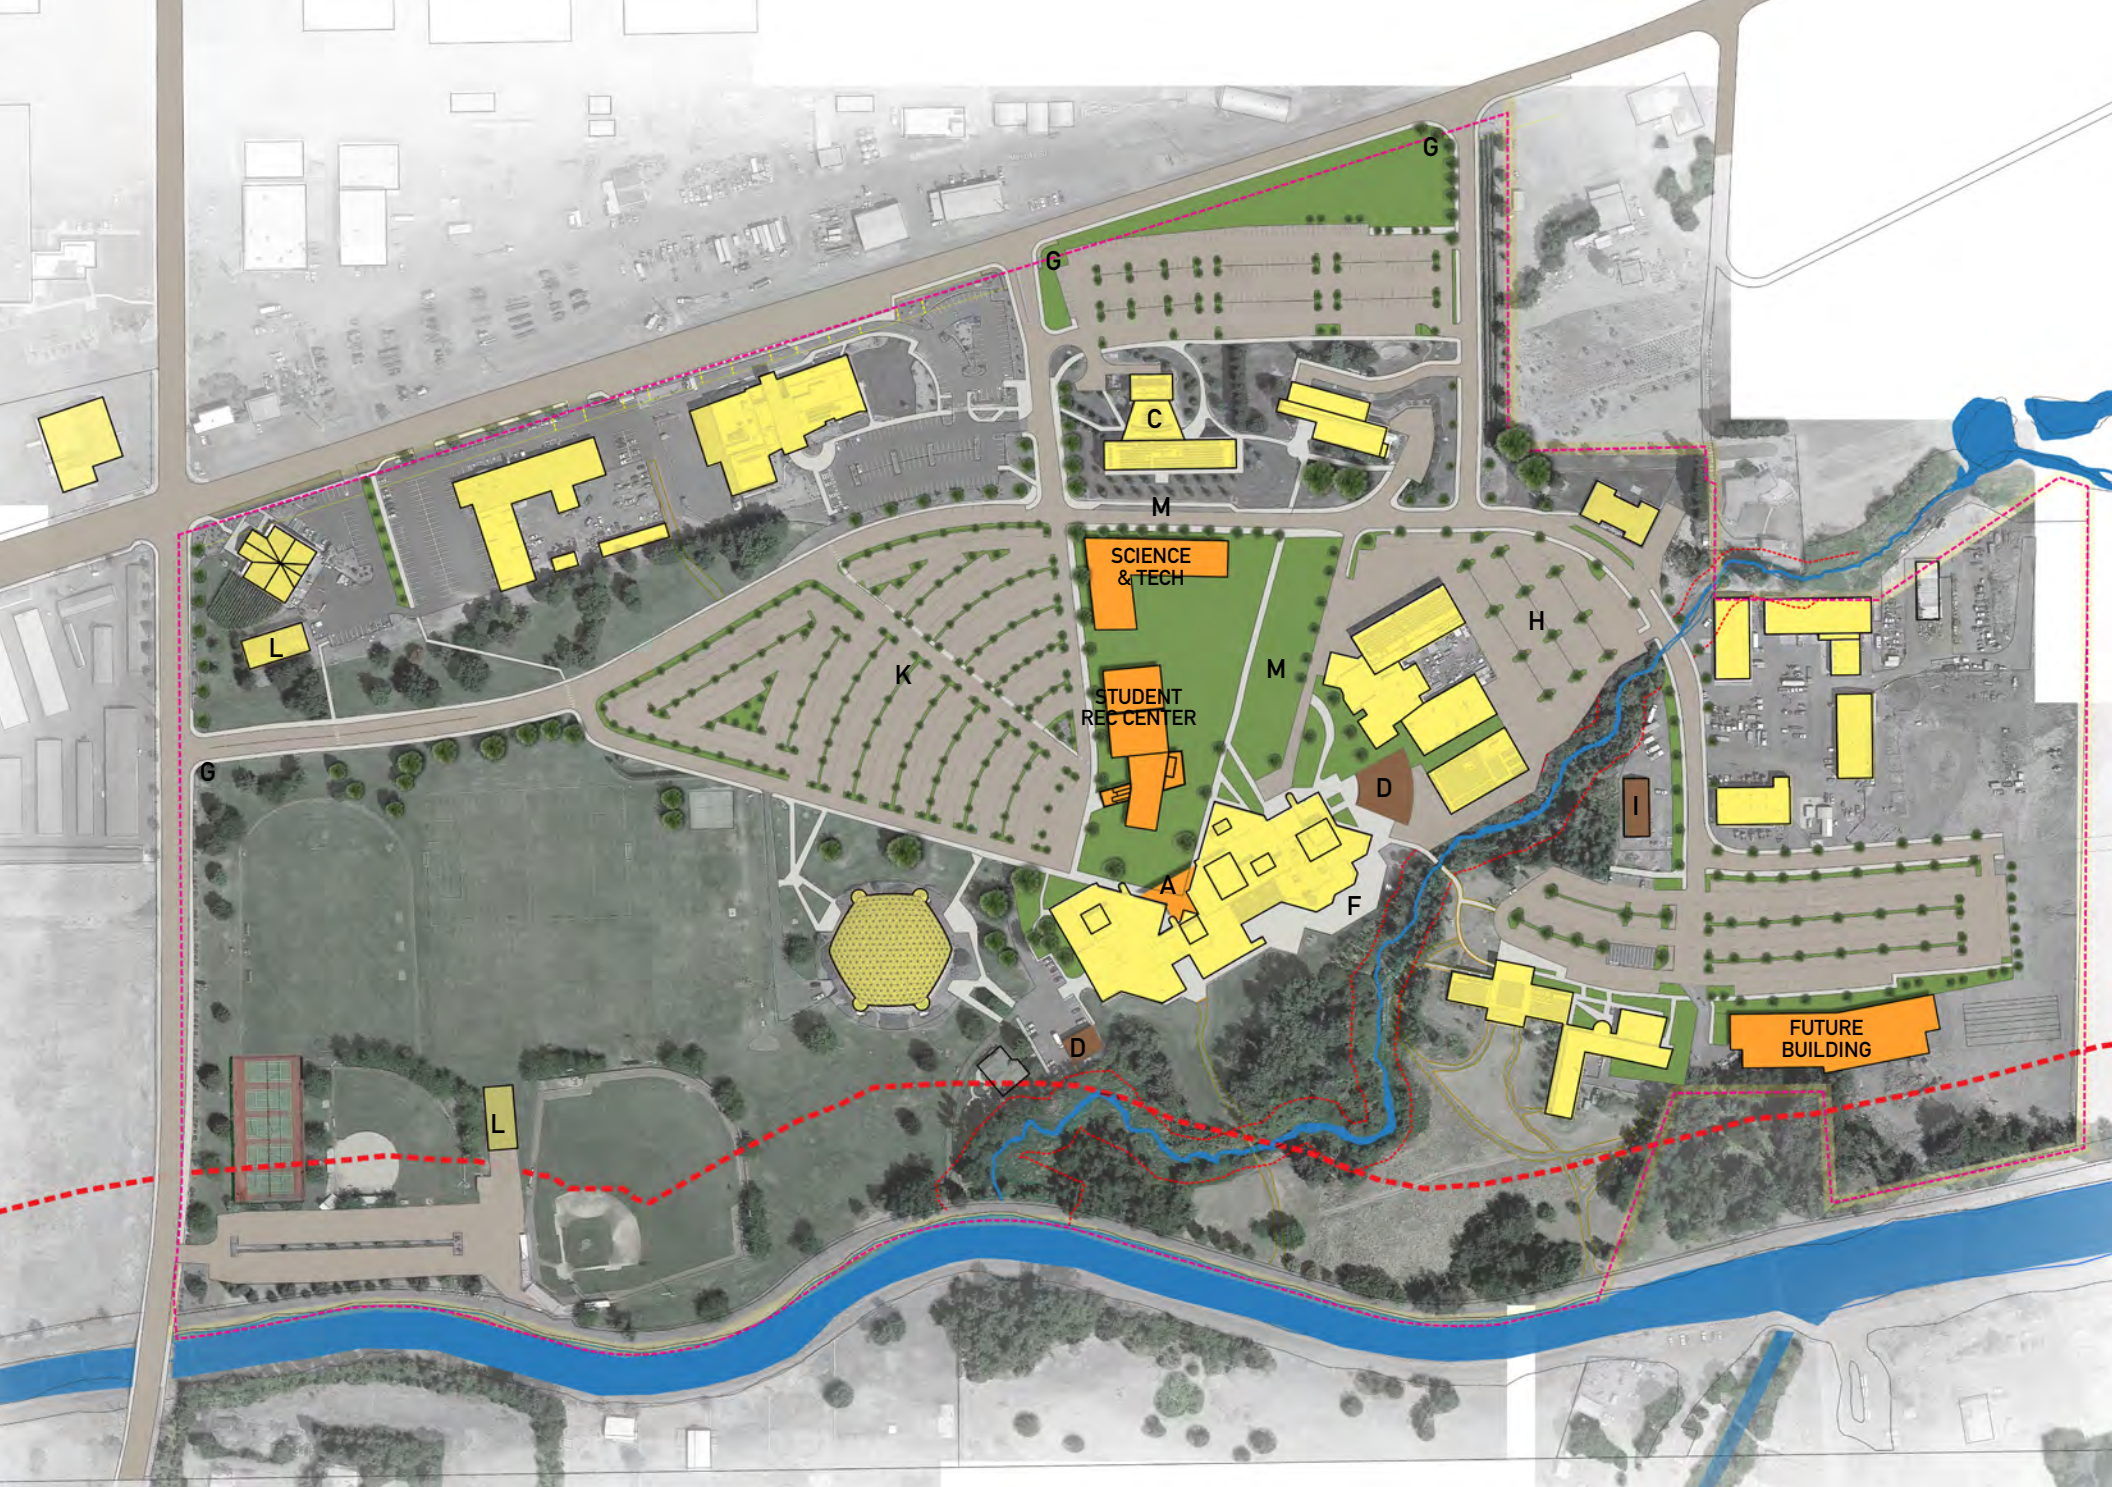
short-term priorities

- A** Front Lawn Improvements: Activate the lawn in front of the Main Building.
 - o Relocate Student Activity Center so it is adjacent to the front lawn and closer to the Student Recreation Center.

- H** Pave Gravel Parking Lot: Pave and landscape parking lot east of Professional Technical Buildings.
- I** Remove Greenhouse: Create outdoor classroom and experimental/specimen garden at current greenhouse site.

- J** Relocate Motor Pool parking lot.
- K** Landscape Existing Parking Lot.
- L** New Batting Cage near baseball fields. Convert to Storage for E&V.
- M** Move Bus Loop: Move parking and bus loop out of center green space.

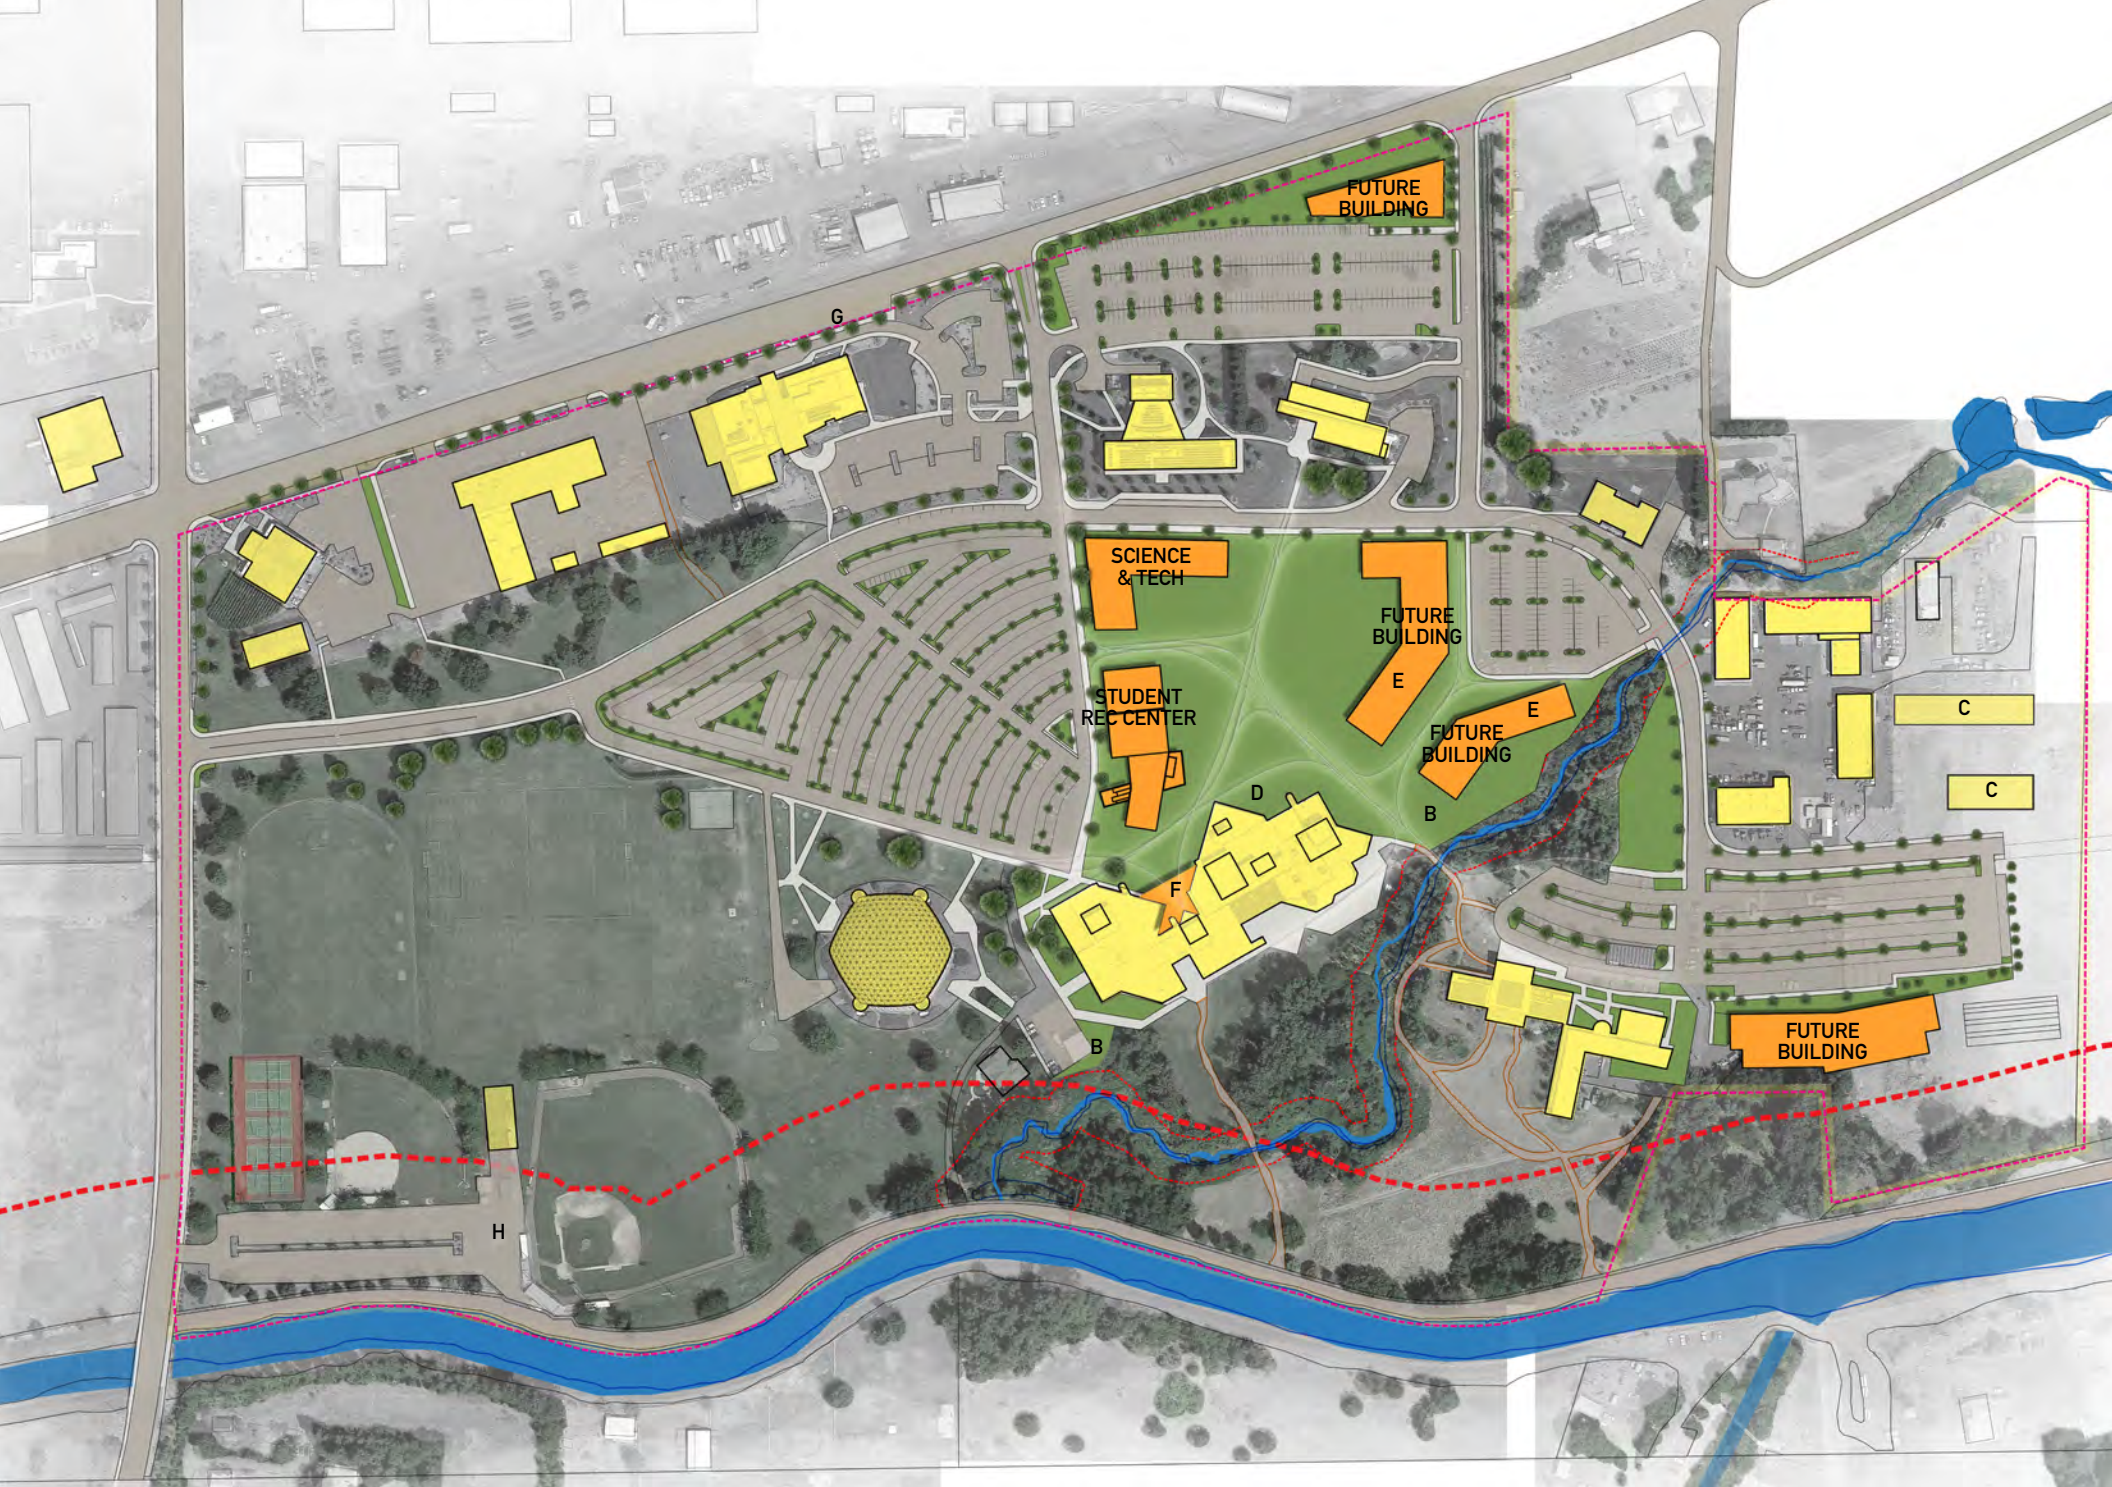
long-term priorities

- D** Move Warehouse: Move Warehouse and Loading Dock from under the Main Building to a location away from the Campus Center.
- E** Professional Technical Building Site: When the Professional Technical Complex exceeds its useful life, replace with buildings that help form a central green space and take advantage of views to Titus Creek.

- F** Upgrade and Remodel Main Building: Add a more inviting and transparent addition to the front and make interior spaces more functional. Space at front addition should include student centered services and visitor information.

- G** Isaacs Avenue Landscaping: Add street trees, landscaping, and sidewalks along Isaacs Avenue.
- H** Improved Access to Southwest Parking Lot and Baseball Fields: Provide lighted pathway connecting southwest parking lot and baseball fields to Main Building.

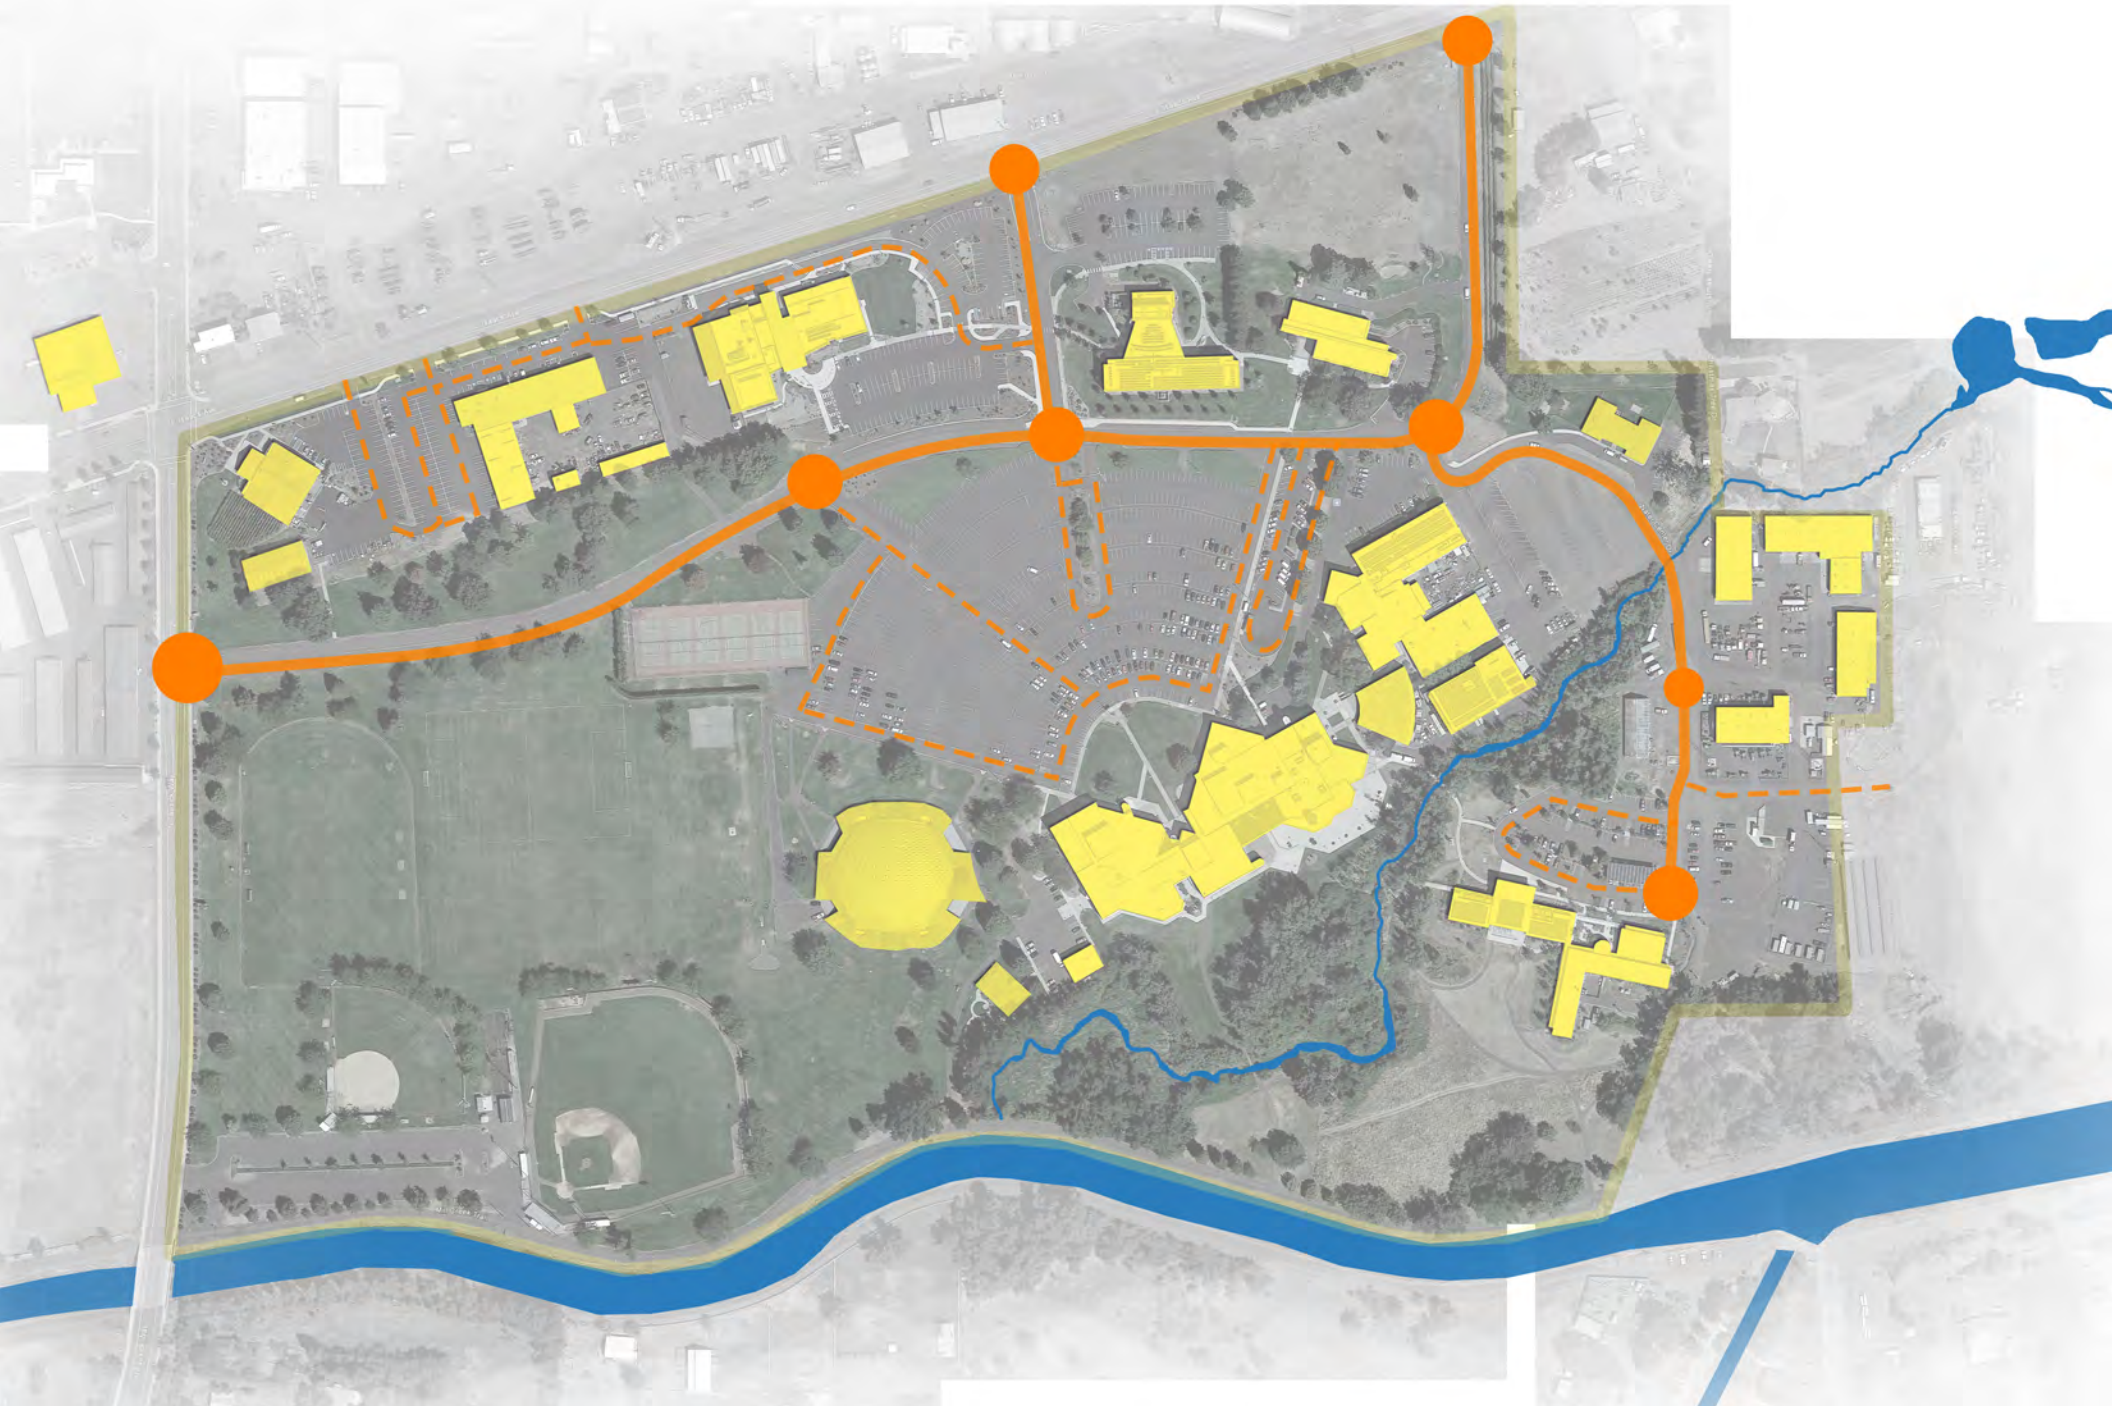
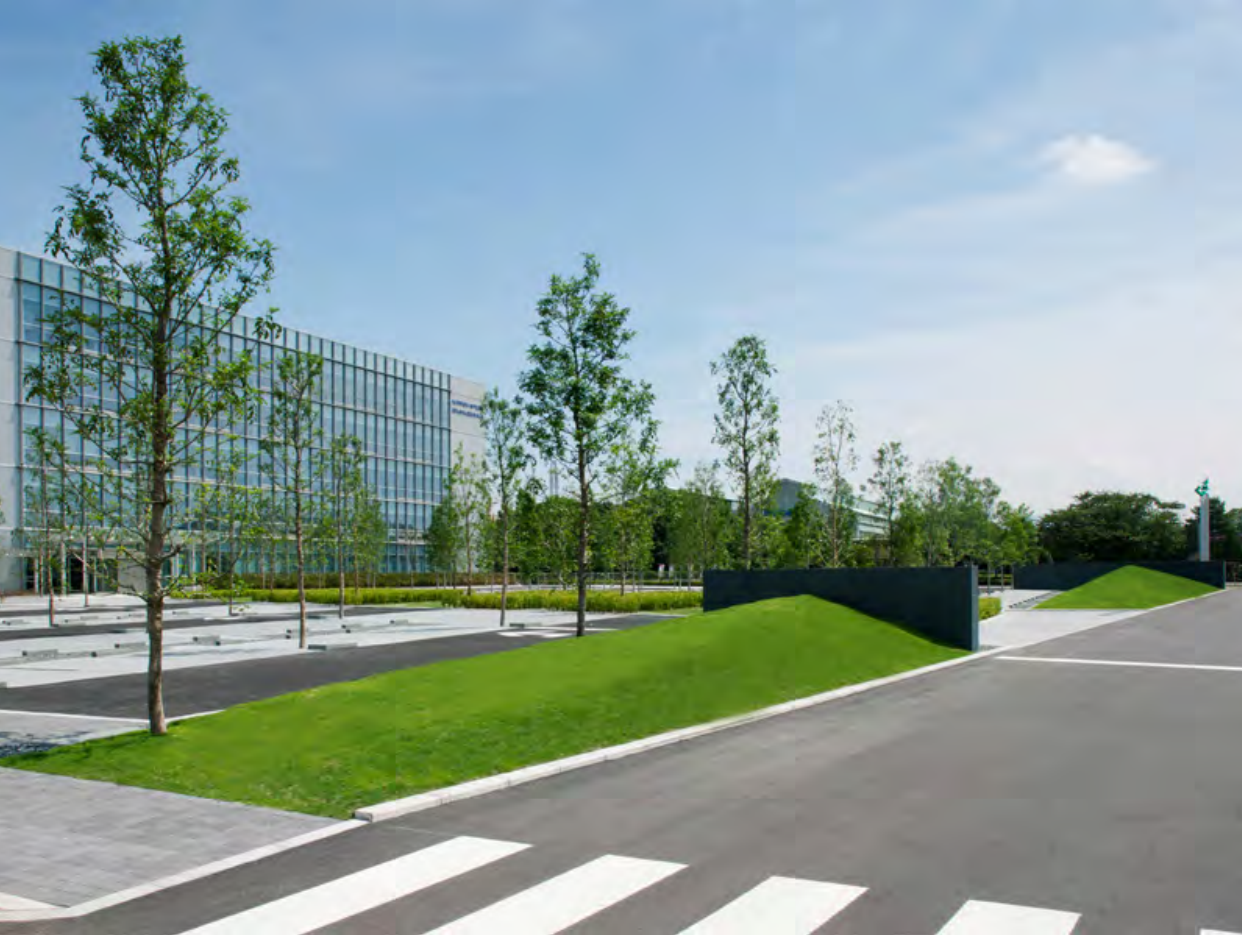
There is a considerable amount of inefficiency in the layouts of several of the parking areas. The large unpaved parking area to the east of the Professional Technical Buildings requires parking stall definition.

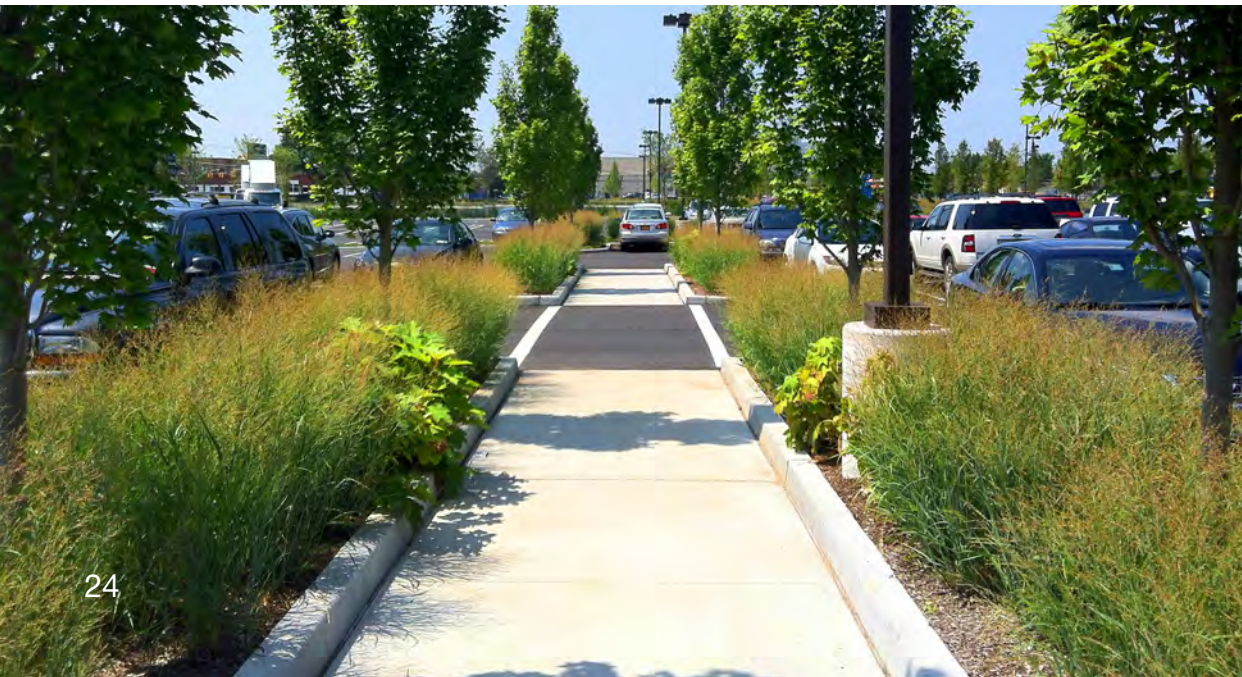
Left Top: Geometric, landscaped berms soften the hardscape of large parking facilities.

Left Bottom: Integrated pedestrian pathways within parking facility surrounded by native landscaping.

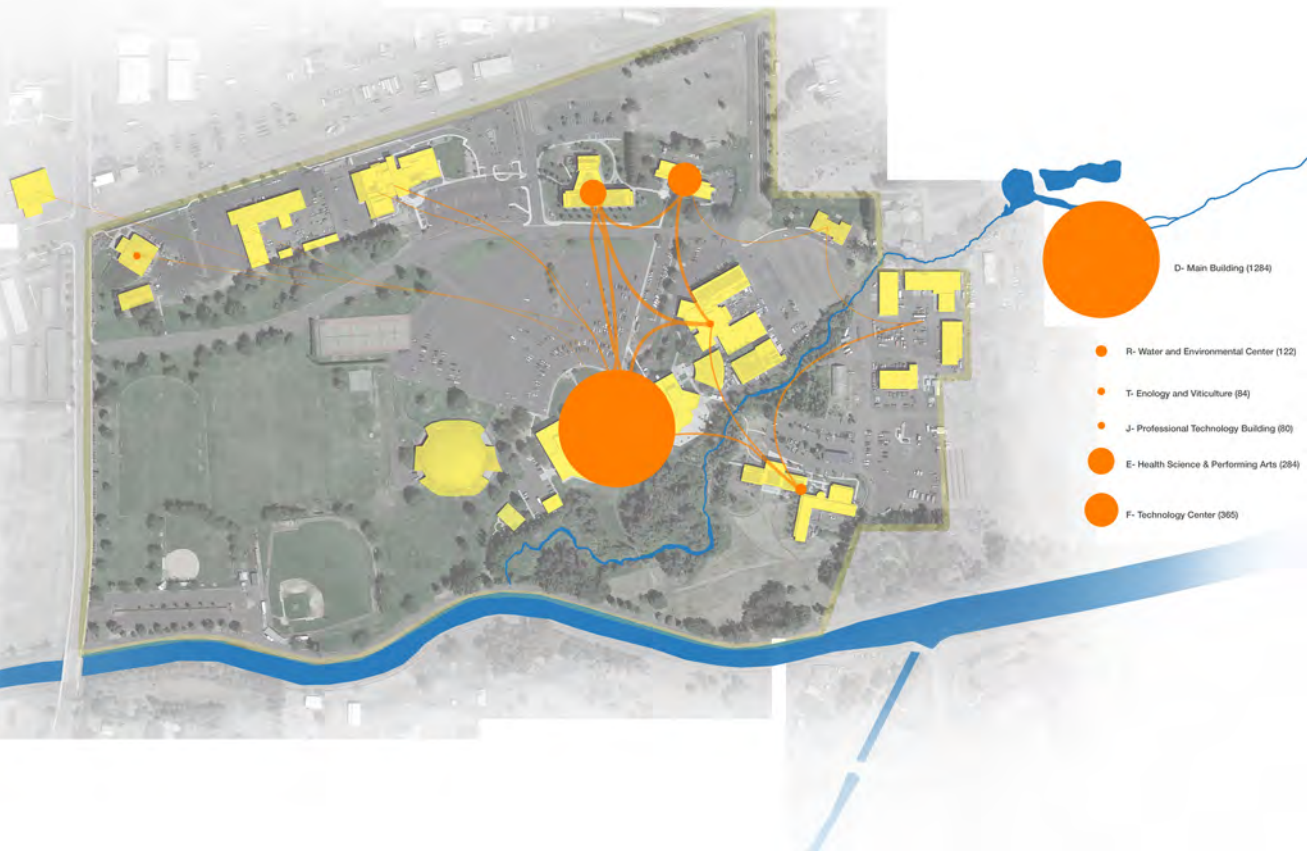
Right: A diagram indicating the pedestrian flow based on the number of classrooms in each building. The strongest connections occur from the Technology Center to the front of, and through, the Main Building.

Left: A diagram indicating student density based on classroom count. **Left Below:** A collection of pathways create an active pedestrian node on campus that help foster chance encounters. **Right:** Main pathways assist in framing particular views on campus of natural and man-made elements.

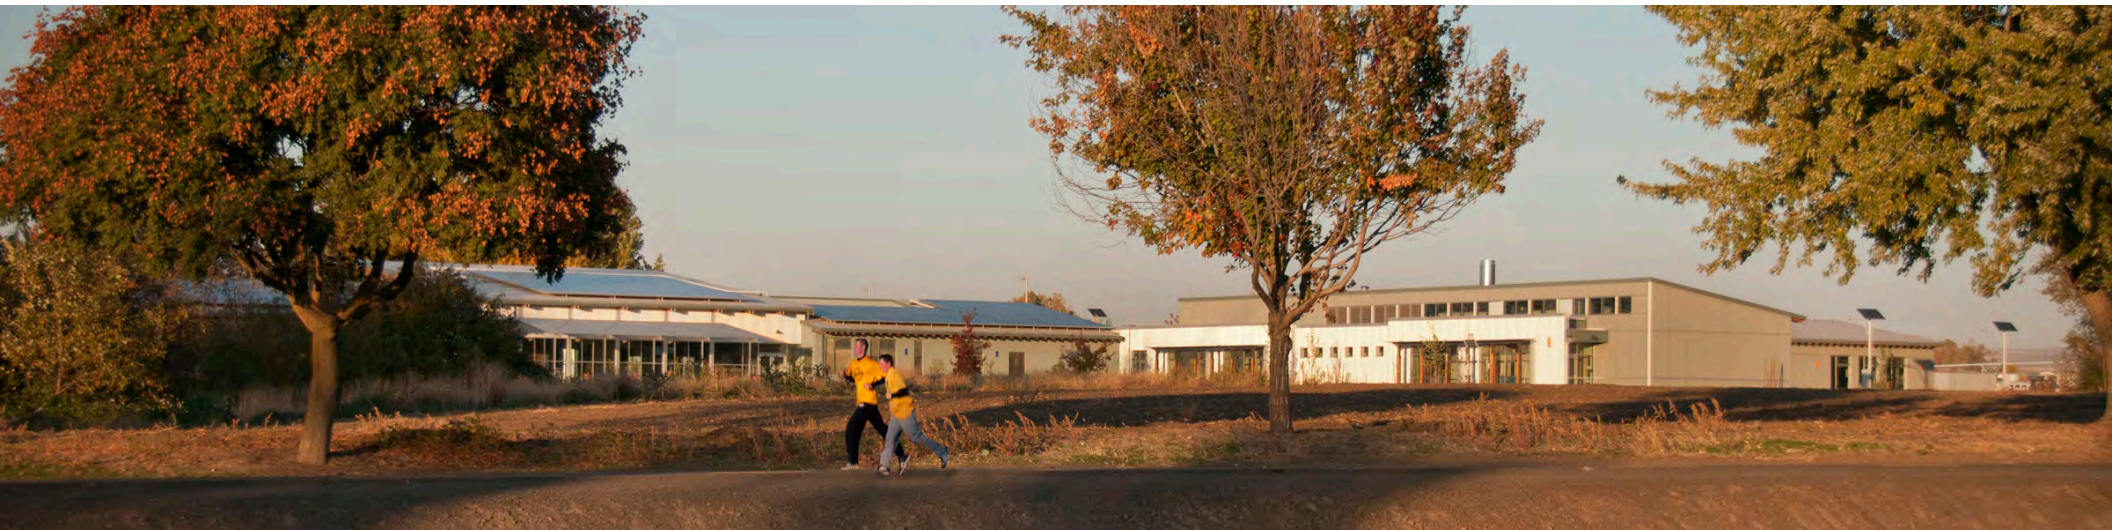
Below: Reinforcing the connection of the public trails along Mill Creek to the heart of campus through pedestrian corridors will encourage students to use other means of travel to get around the Walla Walla Campus.
