Agenda

Board of Trustees, District No. 20

Walla Walla Community College

Wednesday, May 17, 2017

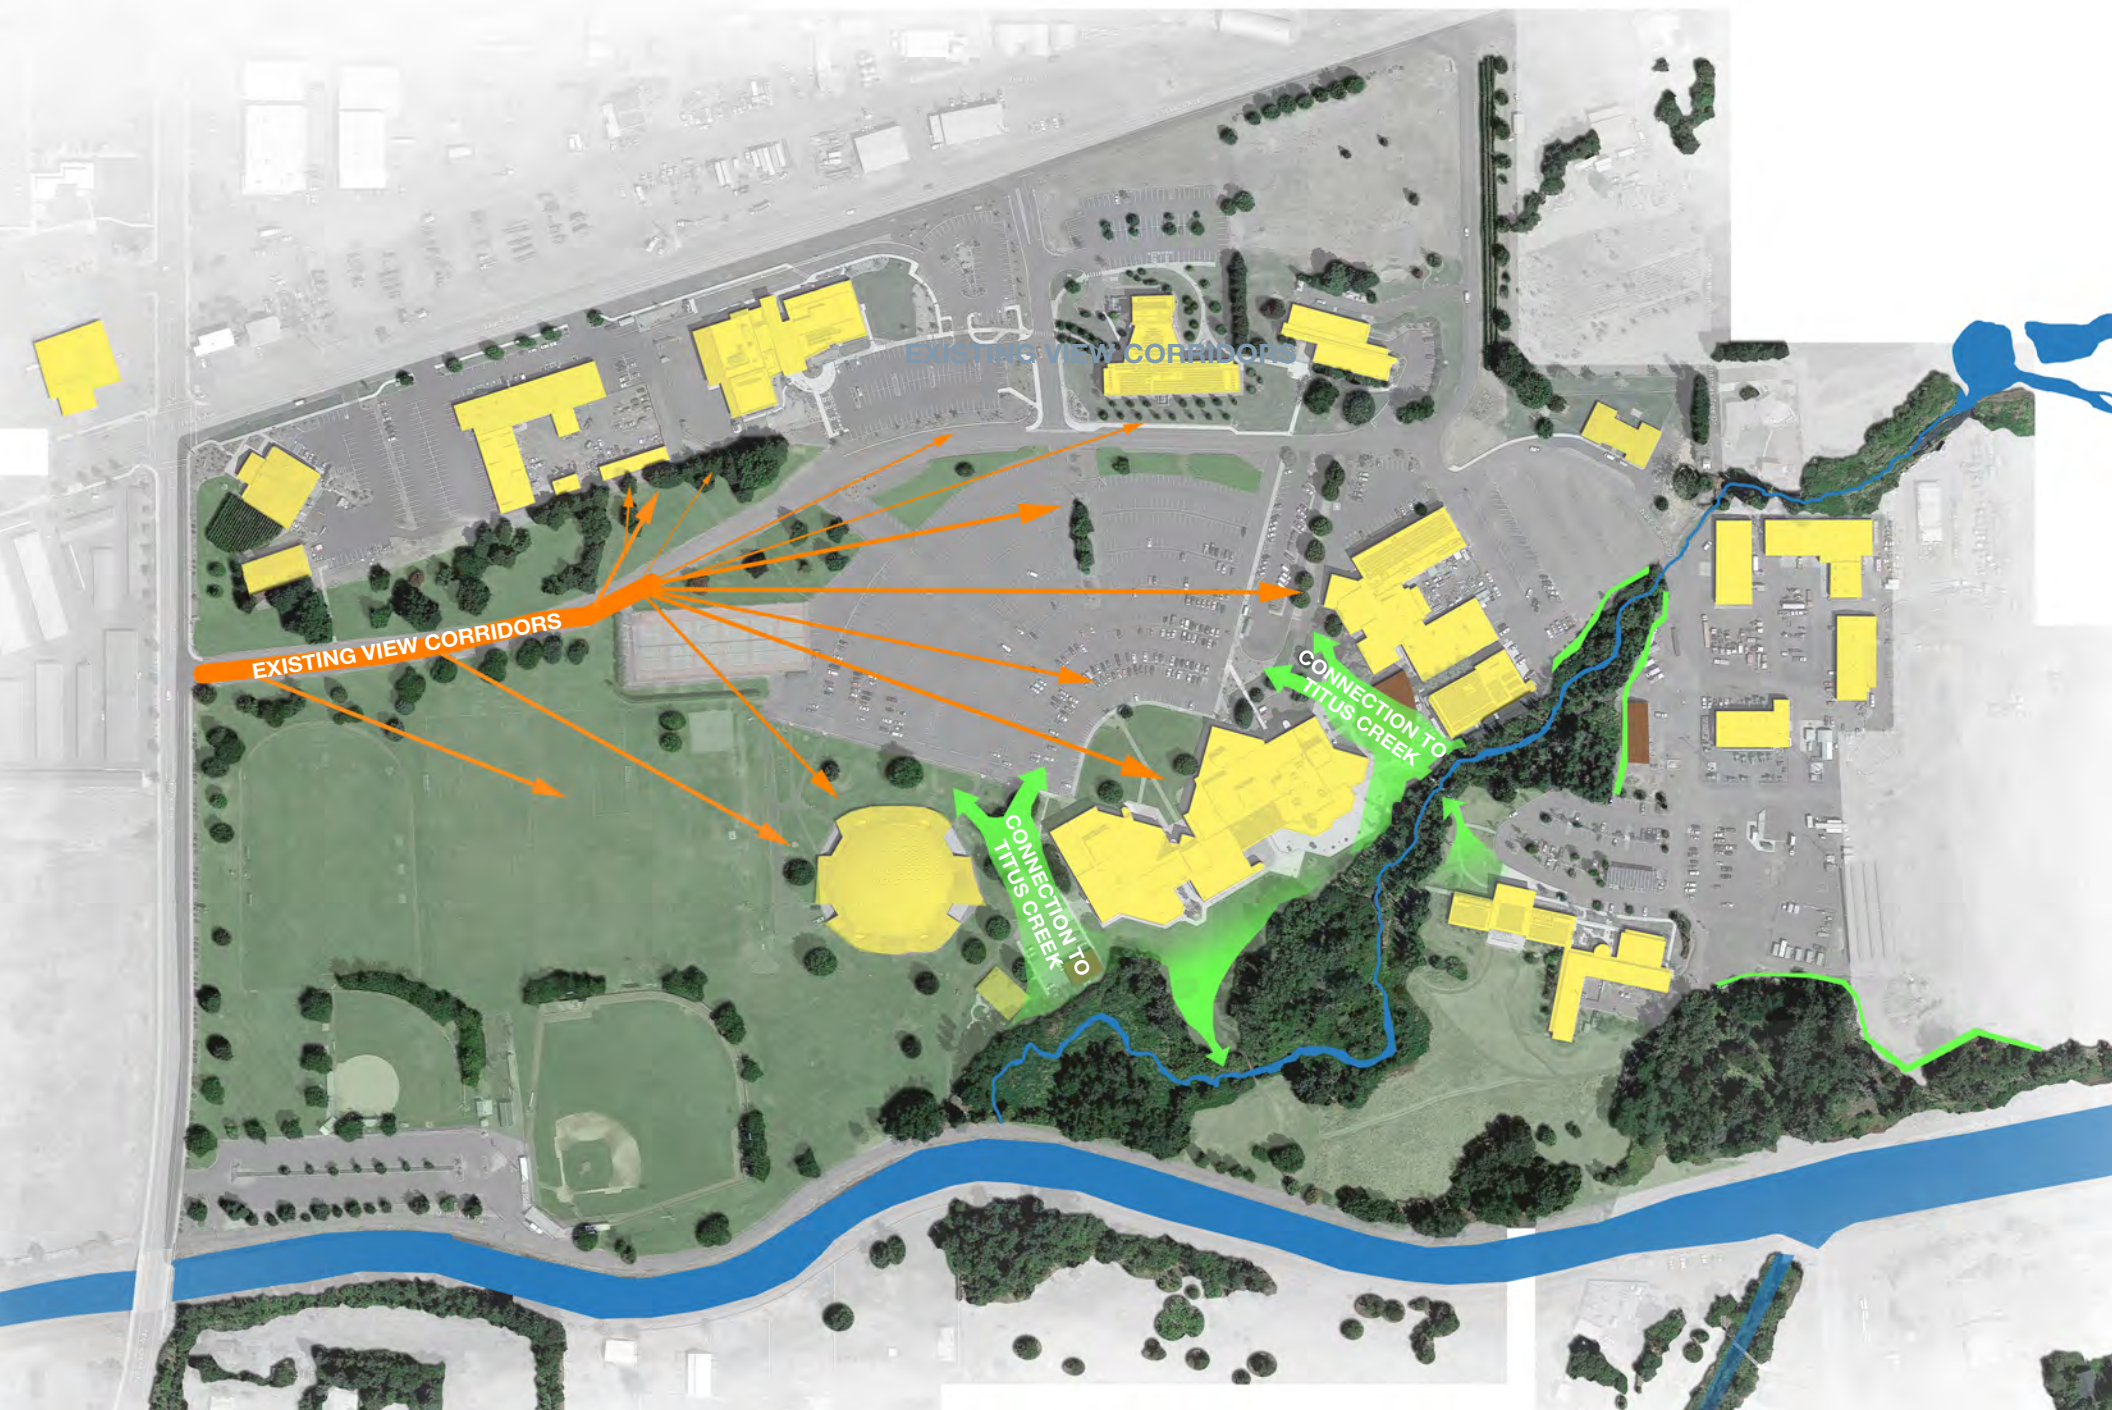
Right: Careful articulation to future building location can assist in the creation of specific view corridors as well as the deflection of unsightly areas geared towards campus maintenance and storage.

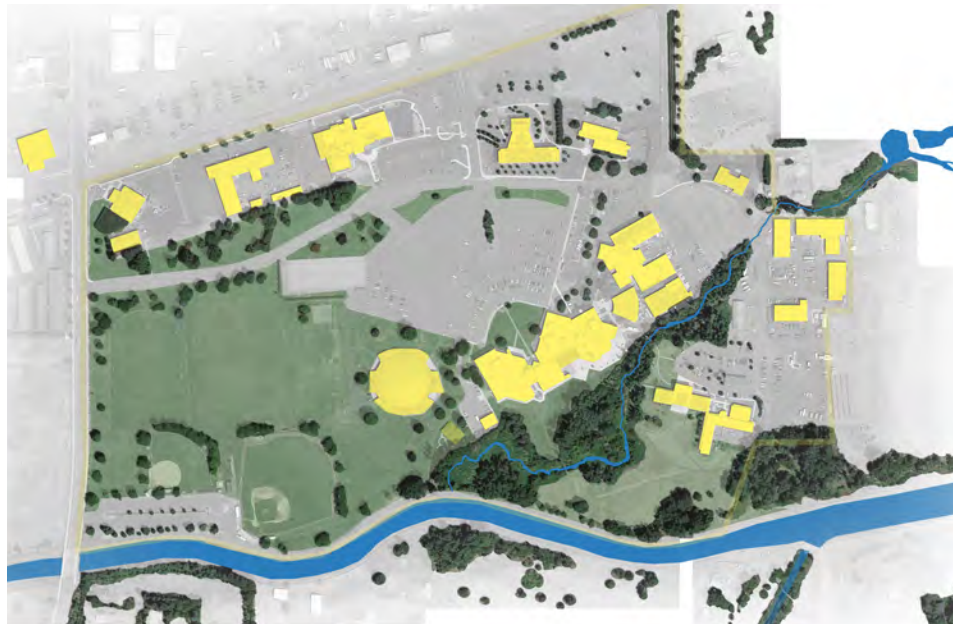
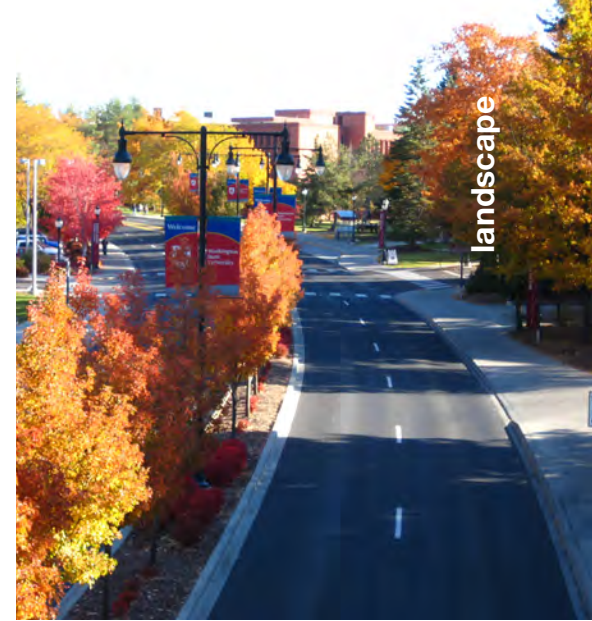
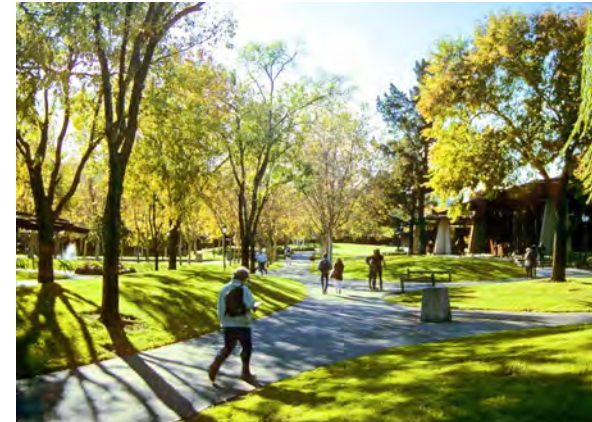
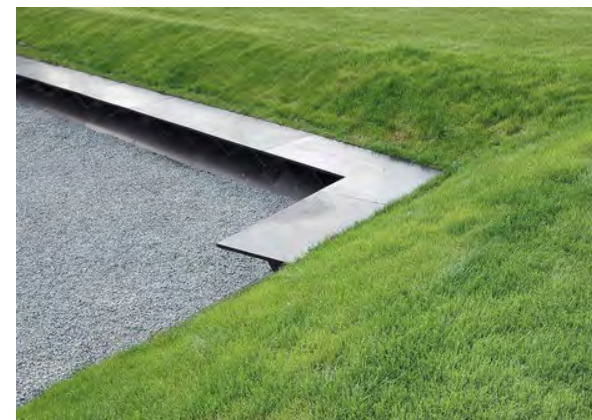
Left: A diagram comparing existing foliage and green space to asphalt and non-landscaped zones. **Right Top:** A more refined and landscaped campus loop helps soften the hardscape and reinforce the natural beauty of the surrounding context. **Right Middle:** Organic campus pathways with a mixture of plantings provides multiple types of outdoor spaces for student use. **Right Bottom:** Introducing specific hard surfaced amenities (i.e. seating surfaces, etc) creates a balanced mixture between the built and natural environments of campus.

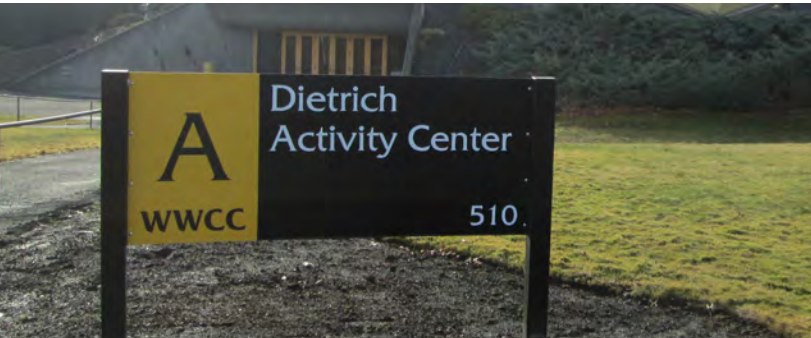
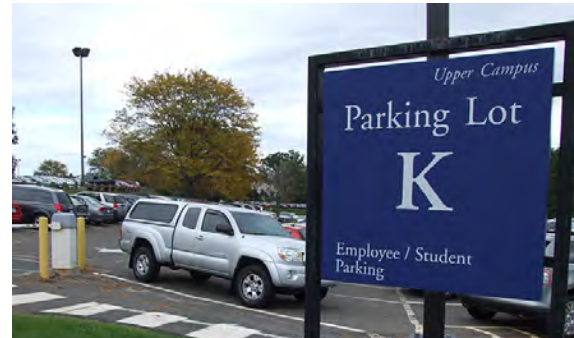
Left: Current building signage & an example for a parking lot identifier
Below Left: Campus entry signage should be striking from a distance and interactive up close. **Middle:** Traffic directional and parking signage may have integrated lighting and should be a marker to enhance campus security. **Below:** Other campus signage may call attention to the natural elements that occur within the campus district and could be fashioned out of more natural materials.

of success. The main building sign suffers in this way, while the Dietrich Activity Center sign does its job quite well. The opportunity exists to take the best of the existing building signs and pattern the others after them. This would help tie the buildings together throughout campus with common design principles.

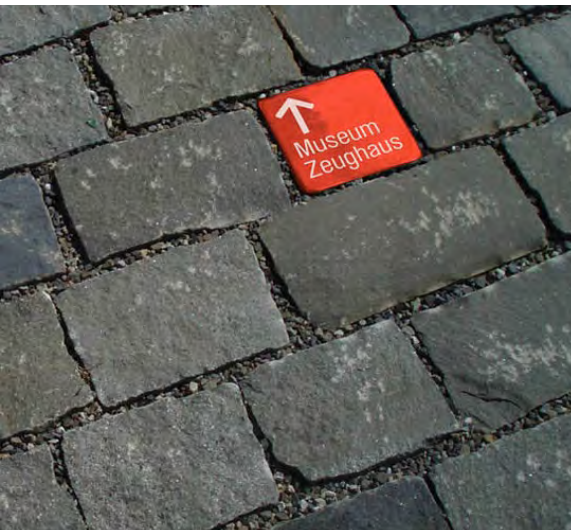
Below: Directional signage inserted into paving system provides additional information without overwhelming the landscape with monument signs.
Below Middle: Creative solutions to interior building signs include innovation in materiality as well as inserting supergraphics in certain locations to aid in wayfinding.
Below Right: Individual room signs can be more striking than the traditional applique.

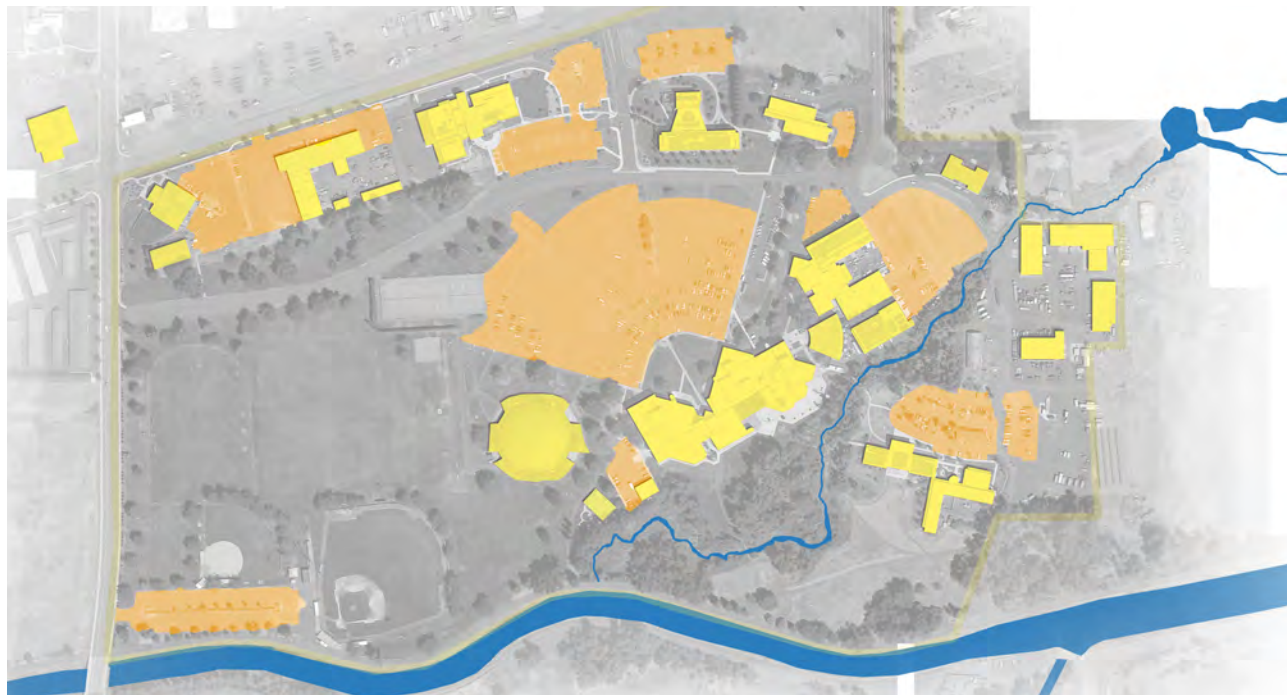
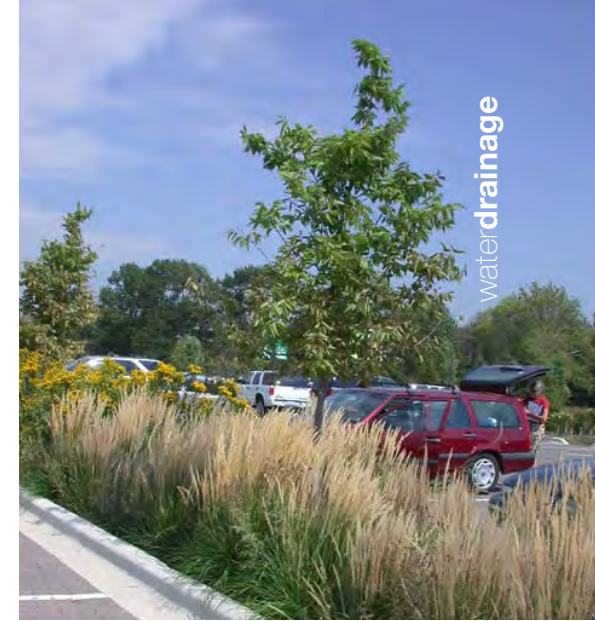
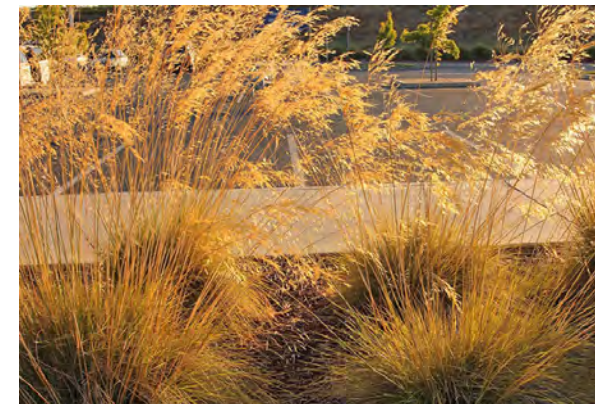
Left: Diagram of existing parking lots
Right: Examples of ways to enhance parking lot drainage

The paved areas near the agricultural buildings are also of considerable concern. This is due to the present condition where the parking areas drain to a catch basin which is piped into Titus Creek. This is a serious problem due to the needed repairs of agricultural equipment, combined with the lack of satisfactory oil / water separators. Pollutants entering Titus Creek and eventually Mill Creek, are the unfortunate result.

At the time of the construction of the early buildings and the main parking area, it was satisfactory to pipe rainwater into established creeks (Mill & Titus), or into sanitary sewer systems. This is now a code violation due to significant environmental concerns and build-up of siltation over time. More recently, engineered collection systems with subsurface percolation is the state of the art for surface water drainage. This method is also now seen to be somewhat problematic due to the inevitable siltation that plugs these systems and the lack of any removal of any hydrocarbons or other impurities. The current environmentally preferred method for dealing with surface water is to utilize bio-filtration swales within landscaping areas. These work best in association with smaller parking areas, which have adequate drainage slope and dispersed roof drainage systems. Essentially, smaller and less concentrated drainage patterns are desirable for both parking areas and buildings.

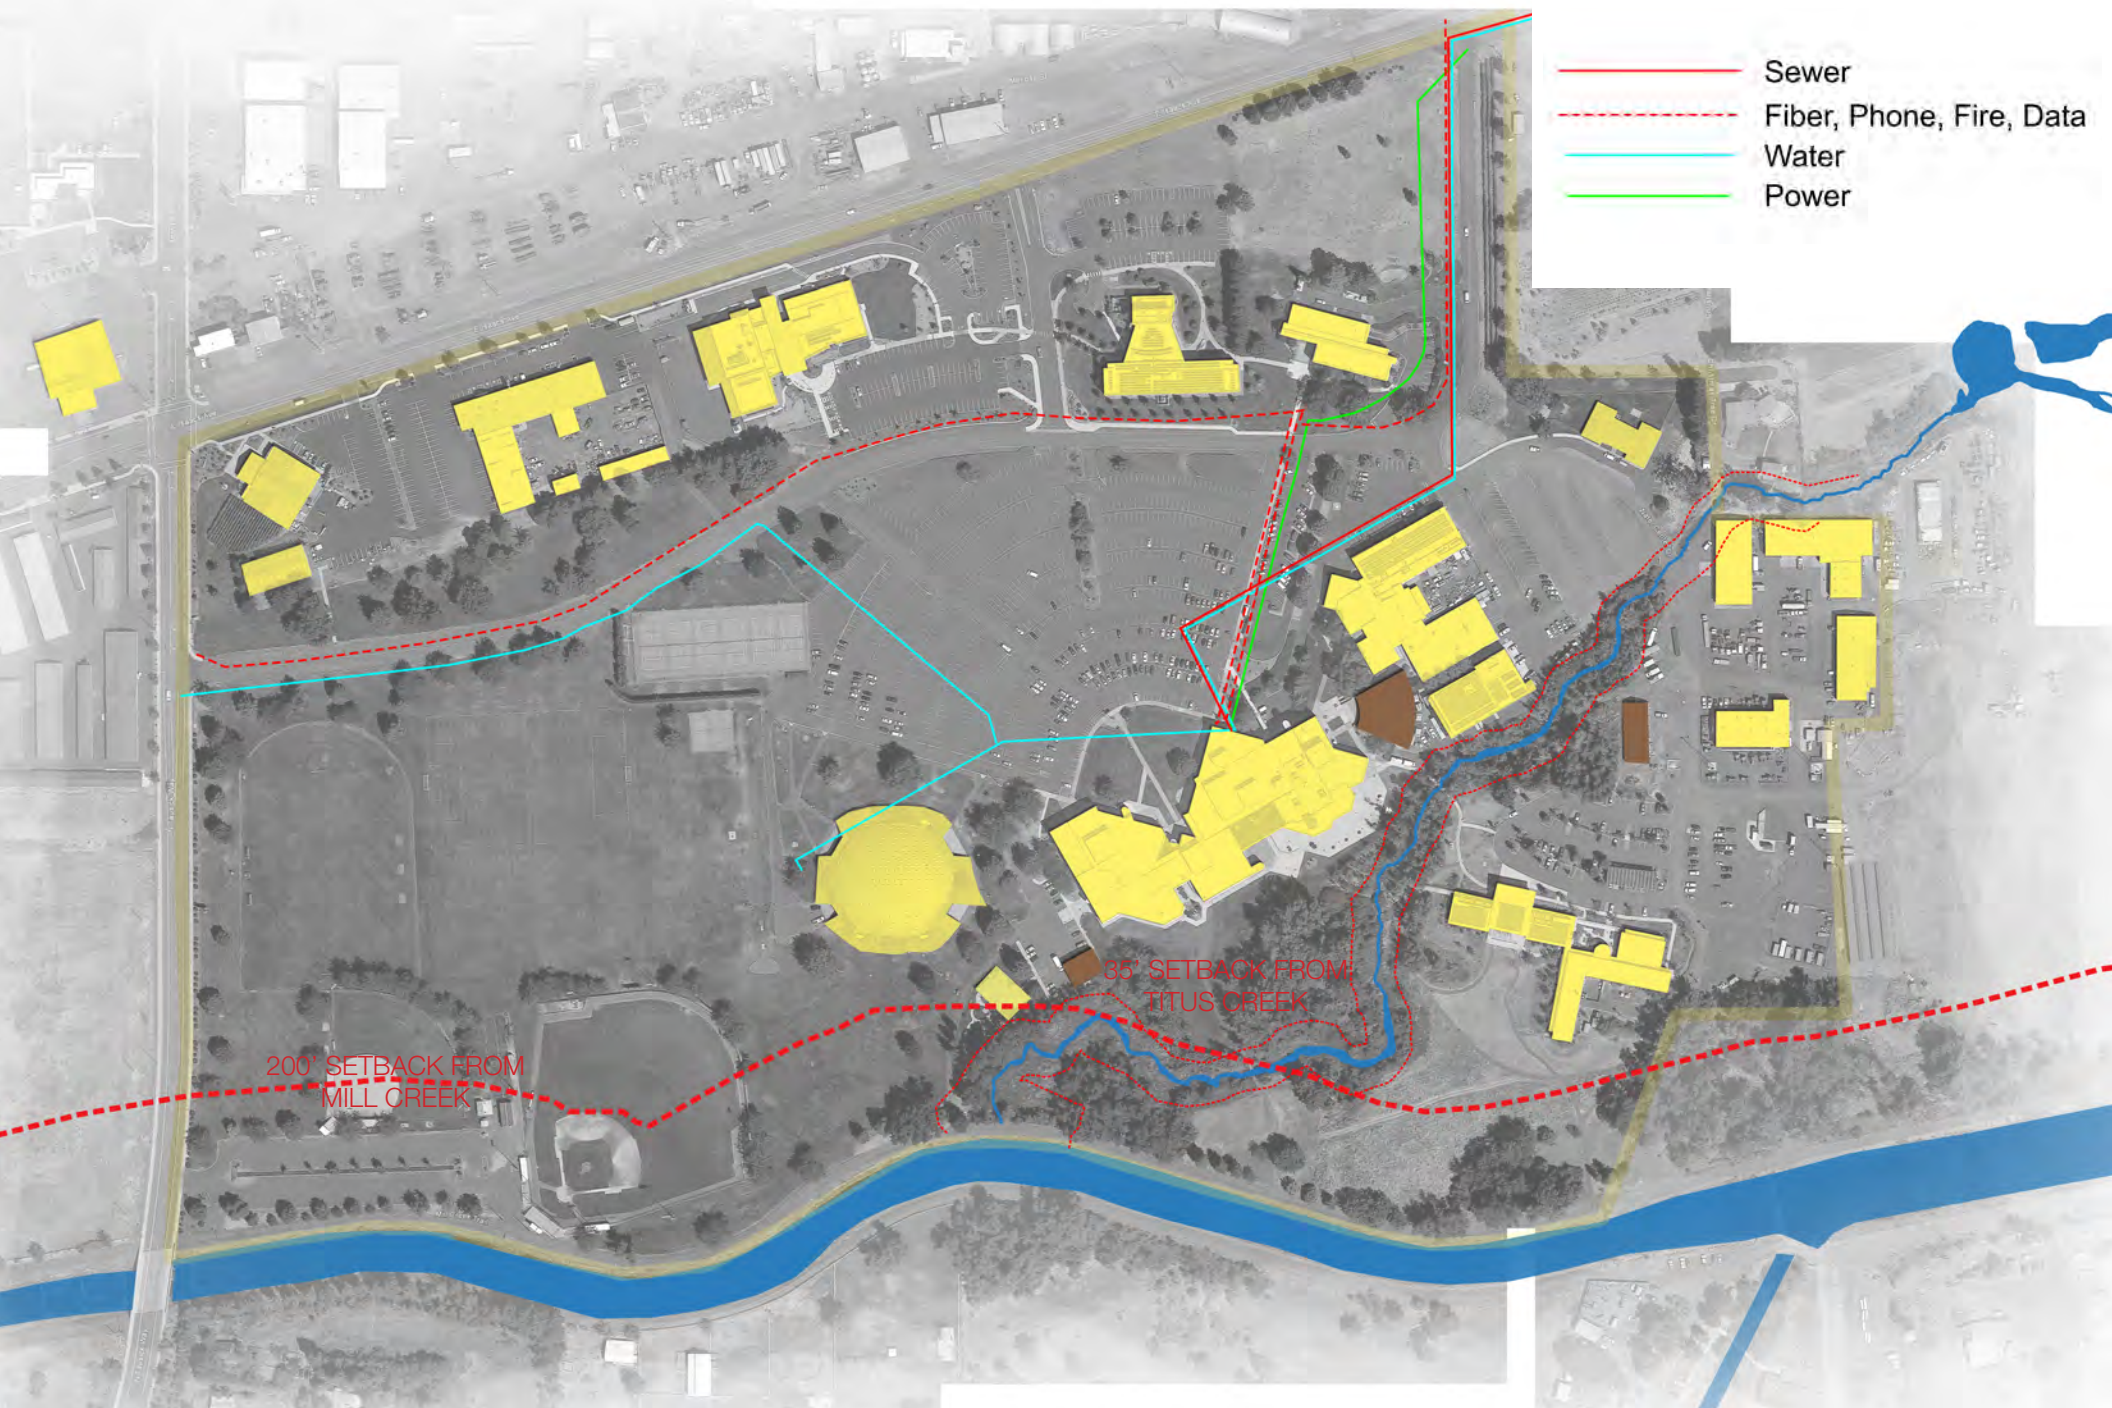
- Sewer
- Fiber, Phone, Fire, Data
- Water
- Power

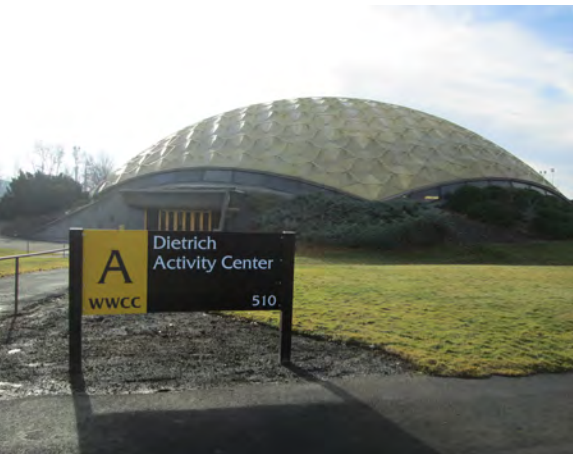
The building is served by several mechanical HVAC units, located equally around the perimeter. The electrical service room is located on the main level at the east side. Plumbing service lines are copper, drain lines could not be seen to determine their composition. No leaks or malfunctions were noticeable with the existing plumbing or electrical systems, however, the domestic water heater seems to take up a considerable amount of space (*gone*) and should be replaced with a more energy efficient one. The building is served by a fire alarm system, but does not have a fire sprinkler system. *Five new 200 gallon gas boiler heater 98% efficient, 4 HVAC, 1 domestic.*

Although no obvious hazardous materials or environmental air quality problems were noticed, it has been quite a while since the ductwork has been inspected and/or cleaned. It would be worthwhile to disassemble and inspect a portion of the ductwork to determine the current condition. It would not be a bad idea to add a few exhaust fans in the weight training room and locker rooms. Asbestos Contaminated Materials (ACM) was not immediately seen to be present.

Entries and exits from the building, along with corridors and locker rooms are in general compliance with ADA and State of WA accessibility codes, except that handicap assist door openers are needed on the entry doors. The toilet rooms are not in compliance. Clearances around fixtures are inadequate and entries do not have the required jamb configuration. The drinking fountains are also not barrier free, as well as the elevator. *No possibility for ADA on the west nor east side. Operator being installed, working on making it compliant.*

- 1 The electrical circuits should be checked and identified.
- 2 The occupancy of this building suggests the need for an emergency power source which would allow safe egress for participants and spectators during a power failure. *Battery back exit lights.*
- 3 The stair treads are significantly worn in many places and need to be replaced. *Not completed.*
- 4 The carpeting is worn in many places. *Not replaced.*
- 5 The elevator does not meet current ADA and State of WA barrier free codes. *Works good.*

- 1 Additional space is needed for weight training.
- 2 Better acoustical separation is needed around the Dance Hall on the second floor. *Completed.*
- 3 Roof seals and roof drains need repair. *Underground drains around the building. Reseal all the joints and check the drains.*
- 4 *Water in the building is a condensation issue.*

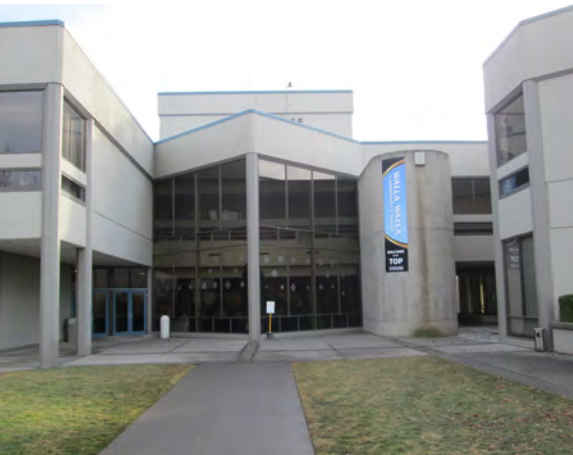
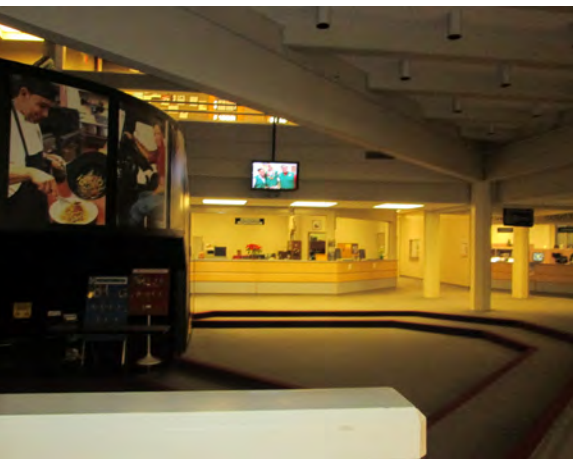
The building is served by a 4-pipe hydraulic mechanical HVAC system, with boilers and chillers located in the basement, as well as gas fired DX units located on the roof. The electrical service room is also located in the basement. Plumbing service lines are copper, drain lines appear to be cast iron. No leaks or malfunctions were noticeable with the existing systems. The building is served by a fire alarm system and all areas have been retrofitted with sprinklers. The fire alarm annunciator panel, fire department hook-up and post indicator valves are not near each other. The main electrical feed for most of the campus comes into Building 200D. The main feed has failed on several occasions and has recently failed (12/24/13) and needs to be reviewed for replacement. The distribution panels are approximately 38 years old and are in need of replacement. *Change to VAV as funds allow.*

Although no obvious hazardous materials or environmental air quality problems were noticed, it has been quite a while since the ductwork has been inspected and cleaned. It would be worthwhile to disassemble and inspect a portion of the ductwork to determine the current condition. Asbestos Contaminated Materials (ACM) were not immediately seen to be present.

Entries and exits from the building, along with corridors and classrooms, are in compliance with ADA and State of WA accessibility codes. The basement classroom (Audio room) is not accessible. The toilet rooms have varying degrees of compliance. Most have been

recently improved with grab bars and other interior accessibility features, however, the entries to most of the toilet rooms do not meet State of WA accessibility requirements due to lack of strike jamb clearance (18" needed with closer). The drinking fountains are also not handicap accessible. The "Warrior's Knee" stepped area on the first floor presents a hazard for the visually impaired. Carpet strips have been added along with handrails to help mitigate some of the issues.

- 1 The ceiling tiles in various locations need to be replaced. If 4' x 4' tiles are used, there are limited choices. One possibility would be to use Armstrong "Optima – Open Plan ". These tiles have a NRC of .95, a light reflectance of .89 and are moisture, impact, and sag resistant.

- 9 The "Warrior's Knee" area on the first floor presents a hazard for the visually impaired as stated above.
- 10 The railing on the second floor at the east end of the building needs an intermediate railing to meet current codes.

- 11 A railing is required on both sides of the ramp in the corridor at the second floor.
- 12 A thorough review of fire & life safety code compliance is recommended to determine the extent of changes needed to the building to meet current fire and life-safety codes. These adjustments may include fire rated corridors and corridor doors, fire sprinklering the entire building, and the need for occupancy or area separation walls.

- 13 Electrical phase protection is needed, with fault indicators. *Replace a fan motors with VFD.*
- 14 The well water circulation associated with the mechanical system should be inspected to determine if sediment is affecting the piping. Investigate the option to hook up a chiller apparatus to the mechanical system using the well water as a heat sink with a heat exchanger so that the well water cannot enter the hydronic piping system. *Repaired. Two new 300 ton chillers and new heat exchangers, 2005-6. Closed 100P. Just air cooling, water goes to the irrigation system.*

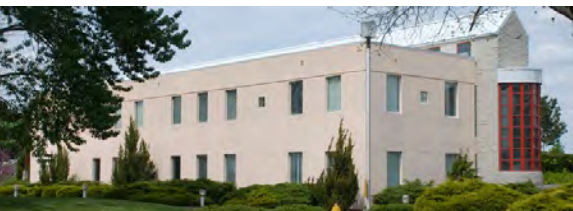
The building is served by a single central mechanical HVAC unit, located on the first floor, with zone dampers. The electrical service room is located next to the mechanical system in a separate room. Plumbing service lines are copper, drain lines appear to be cast iron. No leaks or malfunctions were noticeable with the existing plumbing or electrical systems, however, the mechanical has difficulty managing the different heating and cooling loads. Essentially, the building has zoning problems and is not energy efficient or comfortable. The building is served by a fire alarm system, as well as a complete fire sprinkler system. *Air handler, one boiler, one chiller, new VAV boxes with new dampers. Replace boiler this biennium, new fan motor VFD control. Still has zoning problems but 90% better due to HVAC modifications. Consistent air volume.*

Although no obvious hazardous materials or environmental air quality problems were noticed, it has been quite a while since the ductwork has been inspected and/or cleaned. It would be worthwhile to disassemble and inspect a portion of the ductwork to determine the current condition. Asbestos Contaminated Materials (ACM) were not immediately seen to be present.

Entries and exits from the building, along with corridors and classrooms are in general compliance with ADA and State of WA accessibility codes, except that handicap assist door openers are needed on the main entry doors. The toilet rooms are not in complete compliance. The vanities are too high and the traps need to be insulated. *Not corrected.* The drinking fountains have been made handicap accessible by removing a portion of the walls below them.

- 1 The ceiling tiles in various locations need to be replaced. *Most replaced.*
- 2 The HVAC system zoning is inadequate and the ductwork is quite noisy. A complete review of alternative solutions is necessary. *Somewhat better.*

- 3 There is an on-going effort to replace windows. This process is at the early stage of replacement.
- 4 The stair railings and second floor guardrails do not meet current requirements (containment of 4" sphere).

- 5 A couple of glass blocks are cracked. *Repaired.*
- 6 Efflorescence is visible on the interior of the concrete masonry in many places. Moisture has found a way to penetrate through the block. It has been suggested that this occurred immediately after construction due to "green" concrete masonry. Even so, the window frames and coping at the top of the block should be checked for worn or incorrectly applied sealant. *99% resolved.* The elastomeric coating on the concrete masonry exterior should also be carefully checked for problems.

- 7 Verify the need for a thorough duct cleaning. *1120 1121 (Maintenance) - two rooms replaced.*
- 8 Railings are needed at the steps on the west side of the building to comply with current codes.

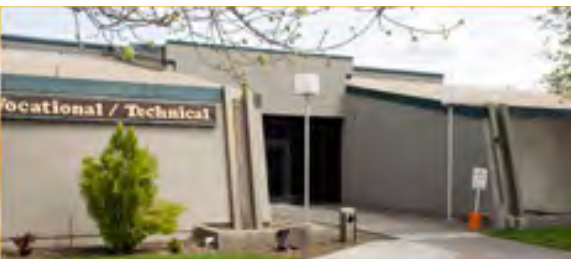
The buildings are composed entirely of precast concrete. The roof and supporting end walls are composed of concrete "T" beam sections spaced at about 10' on center. The side walls are composed of 10' wide flat concrete panels with the exterior walls clad with an exterior insulation and finish system (EIFS). The building has built-up roofing. The newer Music addition and corridor roofing have single-ply membrane roofs. The windows and entry doors are aluminum frames with insulated glazing. *Has BUR been replaced? Yes, solar panels last section last year.*

The building is served by a combination of mechanical systems. Portions #6 & #8 are connected to the four-pipe system from the Main Building. Portions #7 & #9 are provided with suspended gas-powered radiant heat tubes. The electrical service room is located in the southwest portion of the Cosmetology Building portion. Plumbing service lines are copper, drain lines appear to be cast iron. No leaks or malfunctions were noticeable with the existing systems. However, there are leaks on the east side of the exterior wall when it rains. The building is served by a fire alarm system, but only portions of the structure have a fire sprinkler system (building portion #7). *Mechanical tunnel, Carrier all the same.*
